# Re-Cladding the Alaska State Capitol: A Case Study in Rational Historic Preservation

## **Primary Team Members:**

Client:	State of Alaska, Legislative Affairs Agency
Architect:	Jensen Yorba Lott Inc.
Structural Engineer:	Swenson Say Faget Inc.
Building Envelope Consultant:	Paul Lukes: Building Envelope Consulting Services LLC.
Electrical Engineer:	Haight & Associates Inc.
Mechanical Engineer:	Murray & Associates P. C.
General Contractor, Portico:	Alaska Commercial Contractors
General Contractor, Building:	Dawson Construction Inc.

This article concerns the still ongoing re-clad and seismic upgrade of the Alaska State Capitol, scheduled for completion at the end of the 2016 construction season, a project I have been involved with over the course of 11 years.

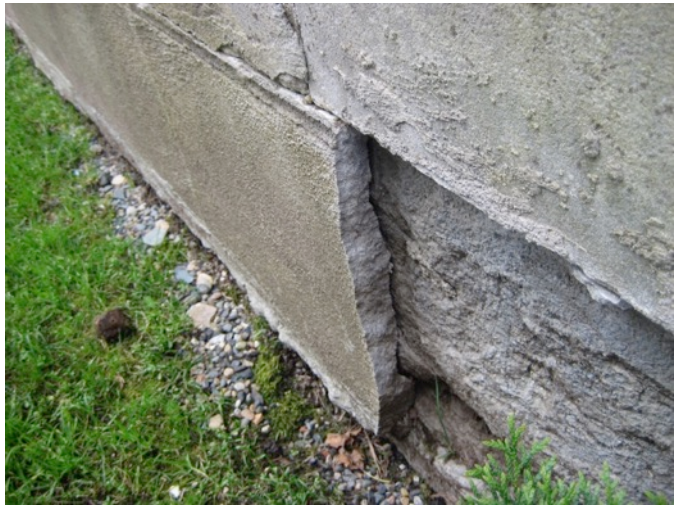
This examination revealed unexpectedly severe masonry degradation and cracking, relatively widespread leakage to the interior, spalling of the stone cladding resulting from anchor corrosion, among many other symptoms. The brick itself appeared very rough as if sandblasted, and contained various cracks, some extending over 10 feet. In short, the building's exterior masonry was in rather poor condition, particularly in view of the building's relatively young age.

**Fig. 1.1: Degradation of Stone Base**

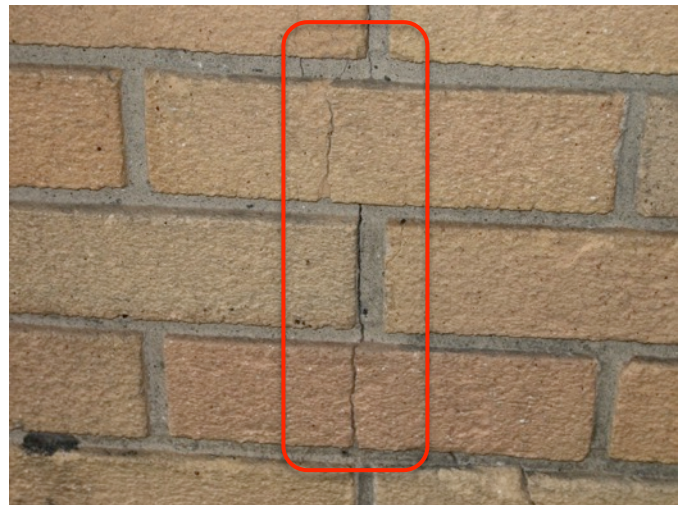
**Fig. 1.3: Brick Spalling**

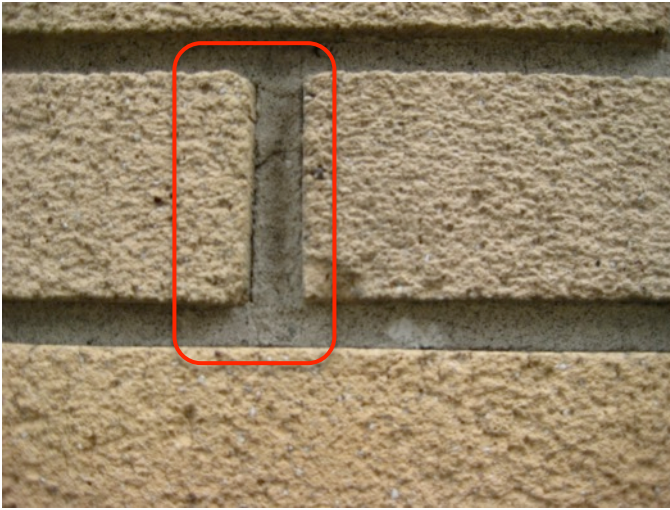
**Fig. 1.4: Brick Erosion & Cracking**

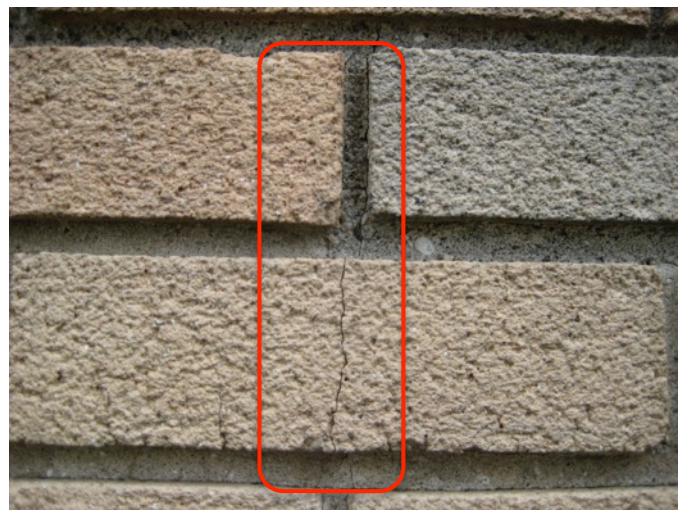
**Fig. 1.5: Erosion, Mortar Delamination**

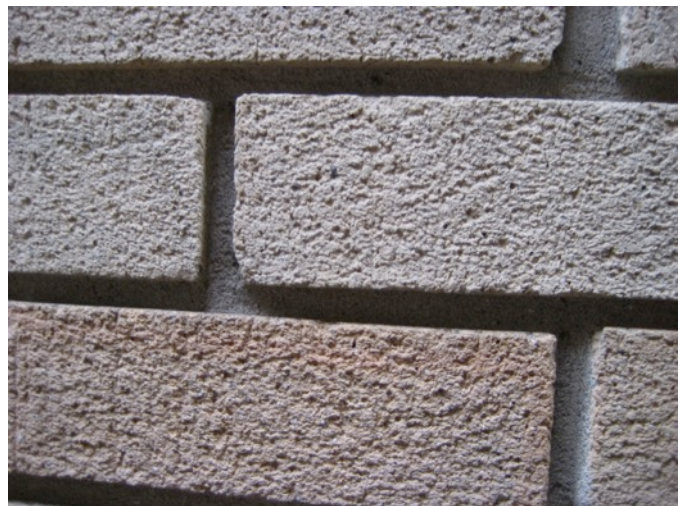
**Fig. 1.7: Brick Surface Erosion & Cracking**

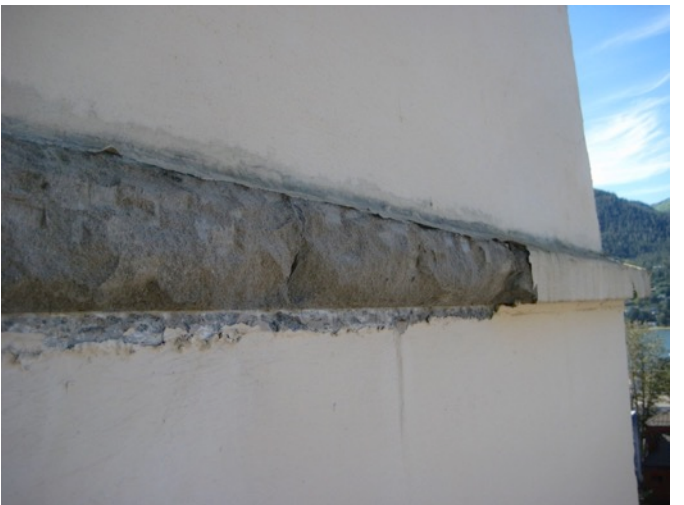
**Fig. 1.9: Spalling Stone Cornice Band**

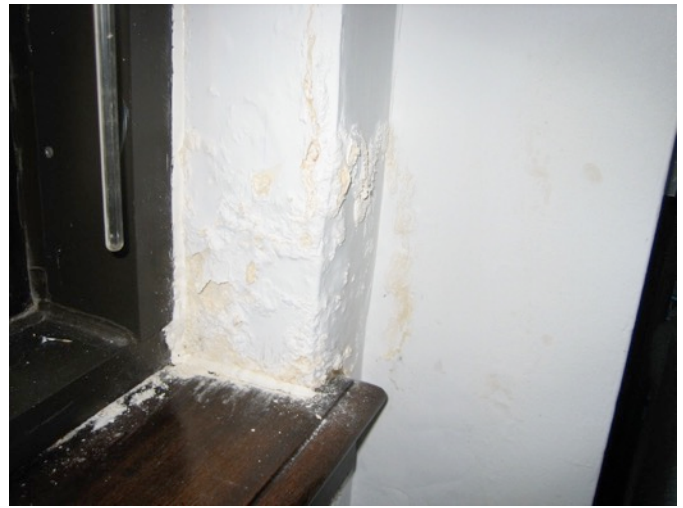
**Fig. 1.11: Water Infiltration to Interior**

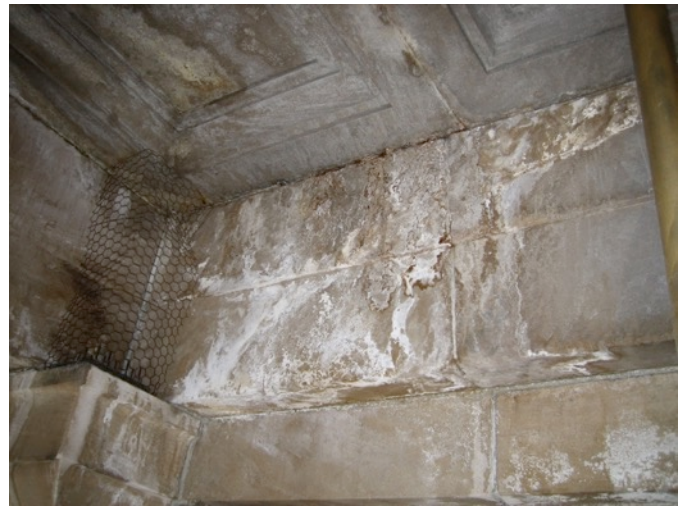
Further, the stone entry portico appeared to suffer both severe water infiltration and associated damage as well as seemingly dangerous cracking of stone beams supporting the portico's roof.

**Fig. 1.13: Water Infiltration Into Portico Clg.**

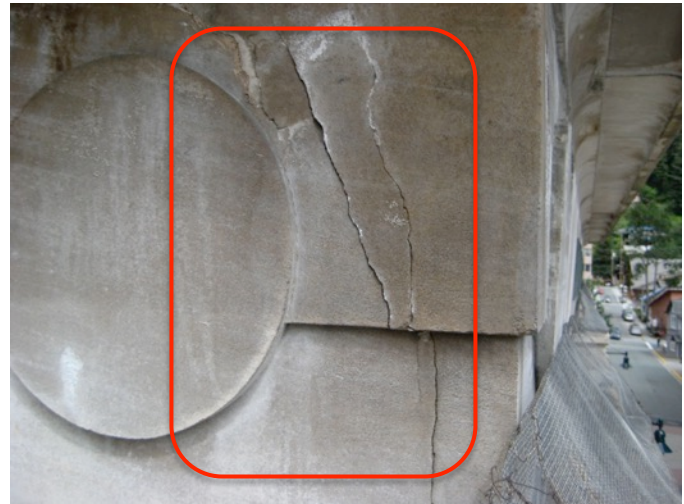
**Fig. 1.15: Cracking of Stone Portico Beams**

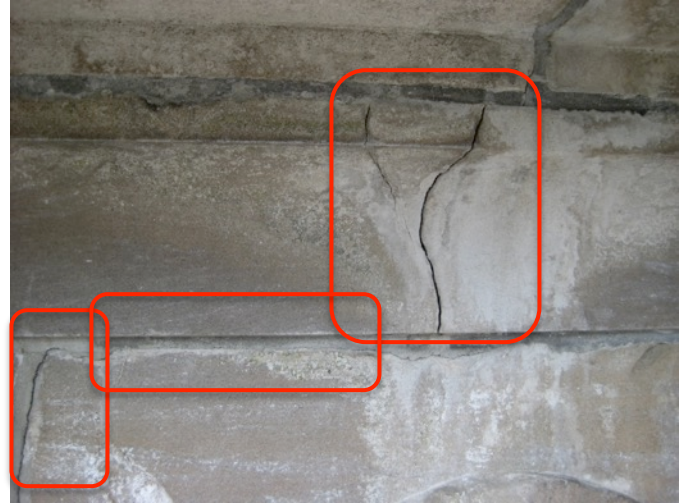
This confirmed my earlier concerns about the portico, whose multi-ton stone structural beams and adjacent window headers were seriously cracked, seemingly vulnerable to collapse in a seismic event. Double-fist sized chunks of stone had already spalled off in the past, apparently from seismic events, onto the granite floor of the entry below.

**Fig. 2.1: Separation of Stone Beams**

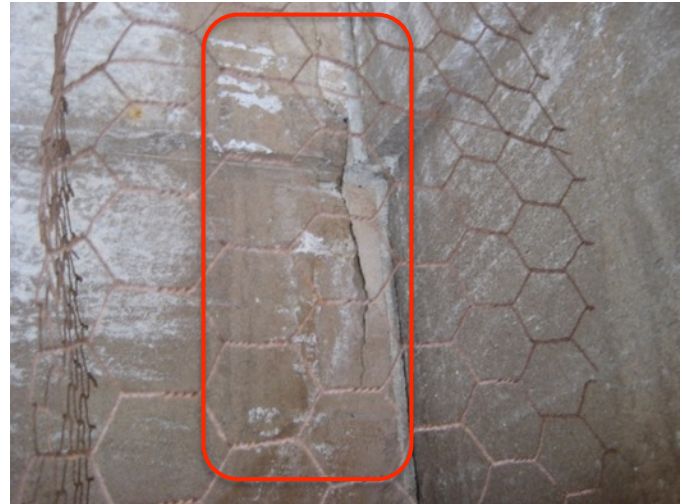
**Fig. 2.3: Spalled-Off Chunk of Stone**

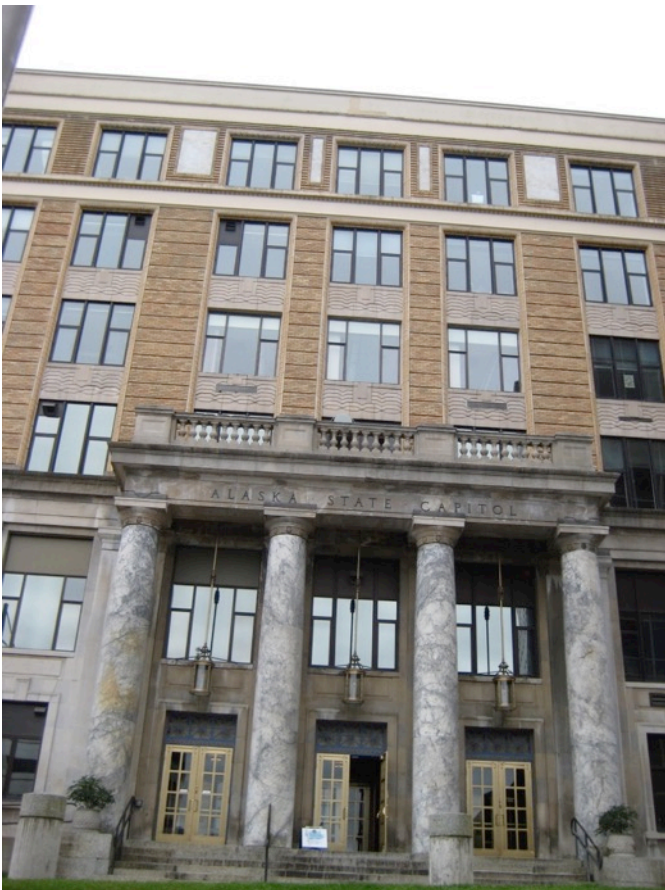
The four marble columns supporting the portico themselves displayed not only serious surface weathering and oxide staining, but also some possibly deep cracking, and while absorption testing indicated these columns to be generally well-sealed, extremely high absorption at even the tiniest of these cracks implied that these fissures may be deep and extensive. Similarly, the granite portico base beneath these columns and abutting stairs showed differential displacement of up to  $\frac{3}{4}$ " in places, revealing significant movement in the past. Per the original construction drawings, the three 8-foot tall, 3-foot wide marble sections, each weighing roughly 13,000 pounds, comprising each column were interconnected only with short "cube dowels" at their joints, making the columns little more than loosely-stacked stones, exacerbating seismic concerns.

**Fig. 2.13: Portico Columns**

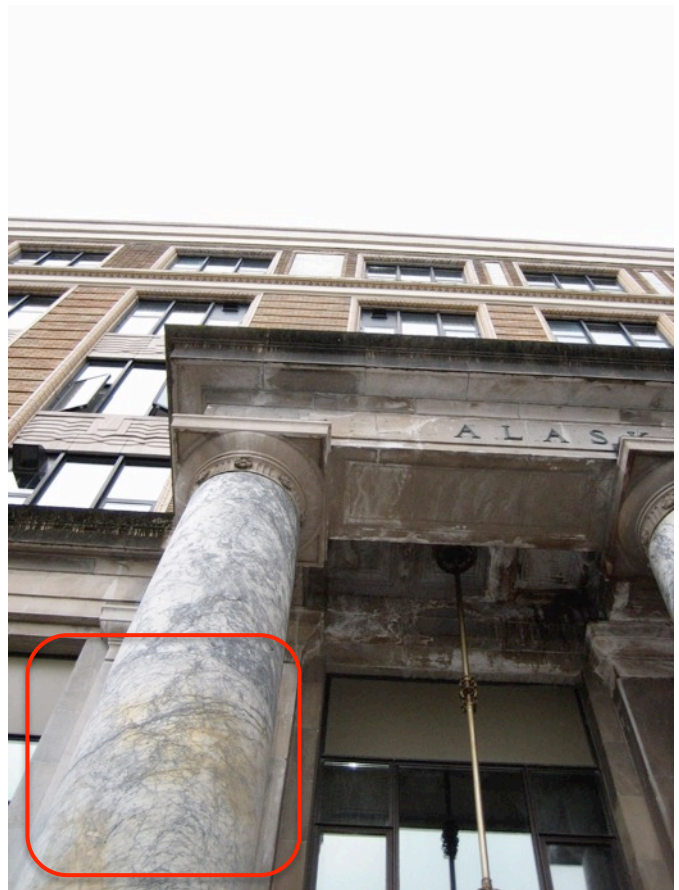
**Fig. 2.14: Oxide Staining on Portico Column**

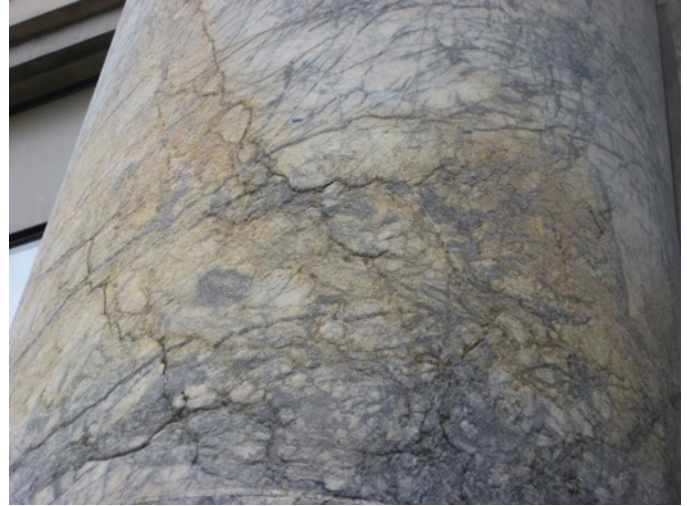
**Fig. 2.16: Staining, Cracking at Portico Col.**

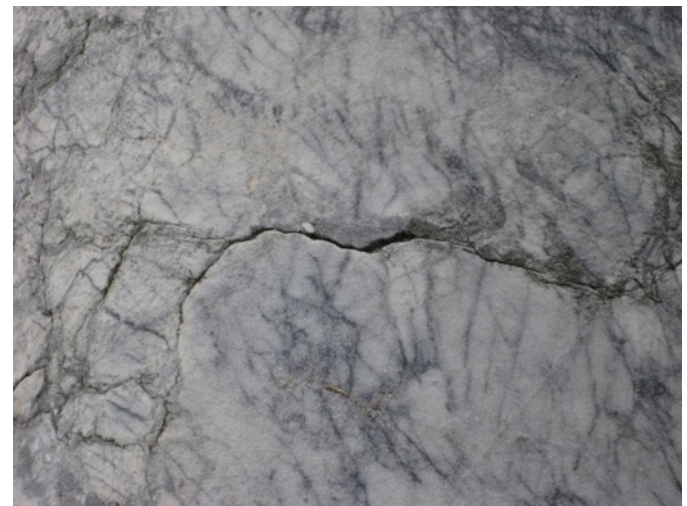
**Fig. 2.18: Cracking at Portico Column**

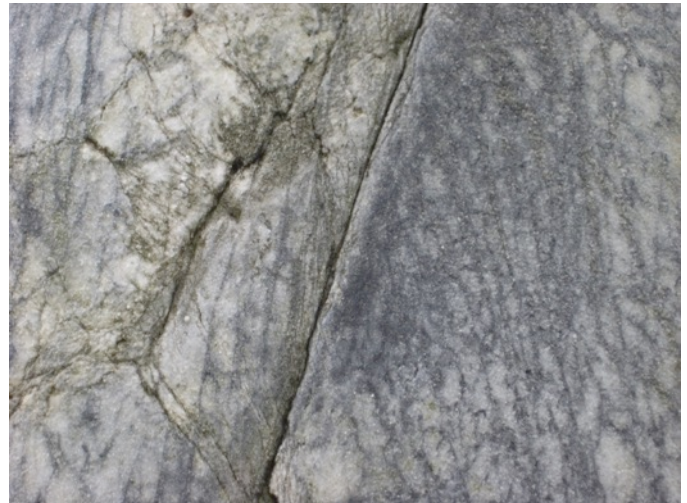
**Fig. 2.20: Cracking at Portico Column**

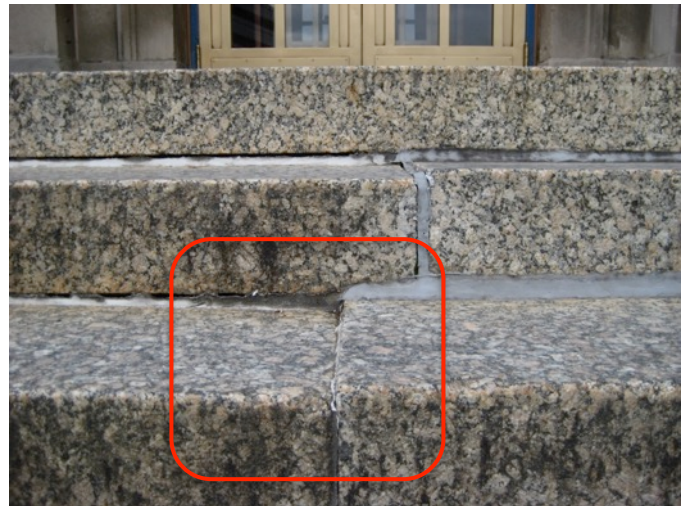
**Fig. 2.26: Downward Displacement at Stair**

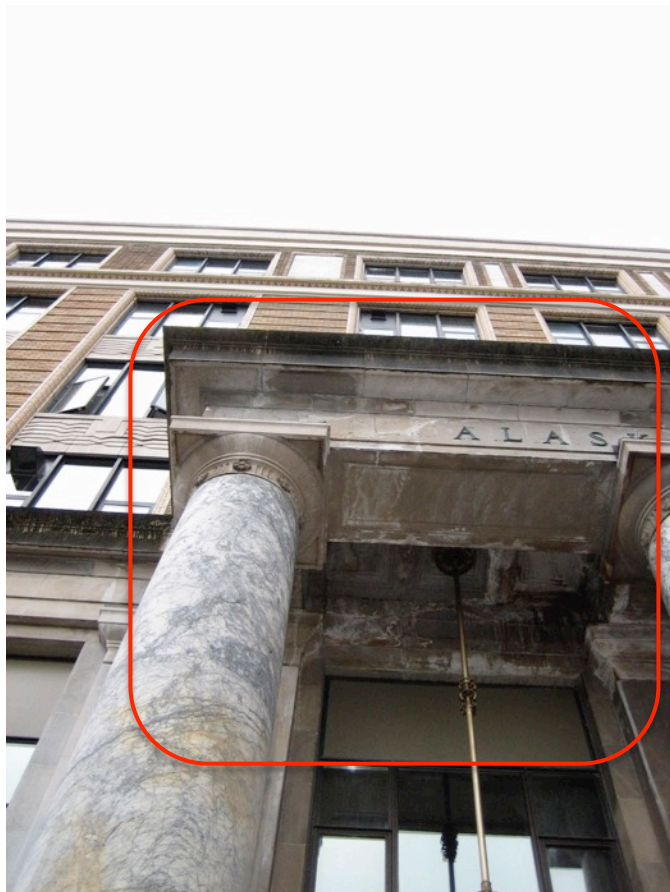
Further, it was clear from the severely stained, in places eroded stone ceilings that water had been seeping down through the portico deck structure since its original construction, causing 80 years of water damage and probable corrosion of reinforcing steel embedded within the portico's concrete deck and beams.

**Fig. 2.33: Severe Staining of Portico Ceiling**

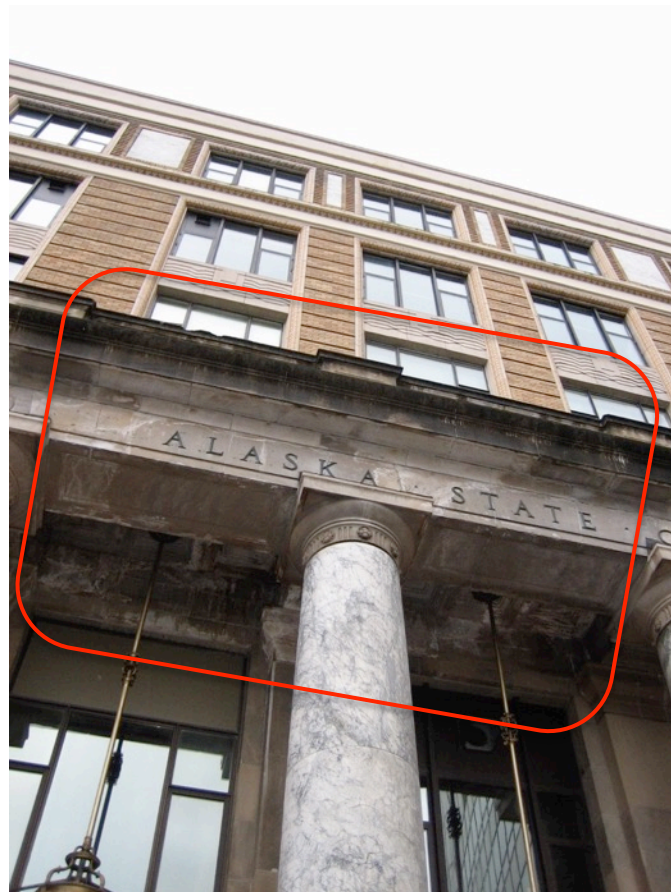
**Fig. 2.34: Severe Staining of Portico Ceiling**

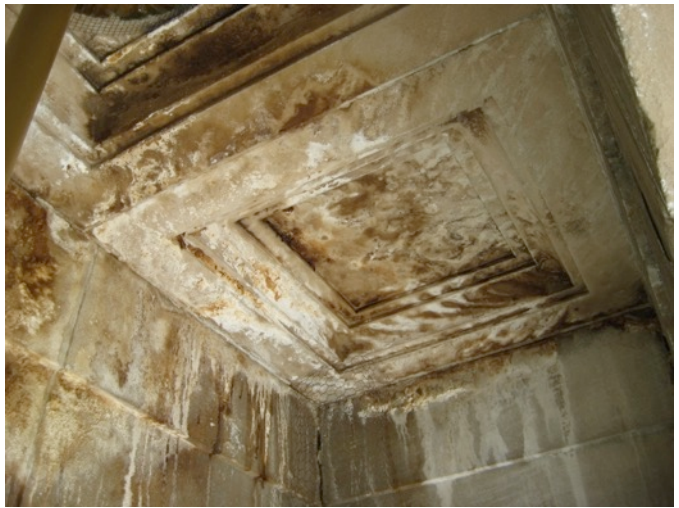
**Fig. 2.38: Staining & Erosion of Portico Clg.**

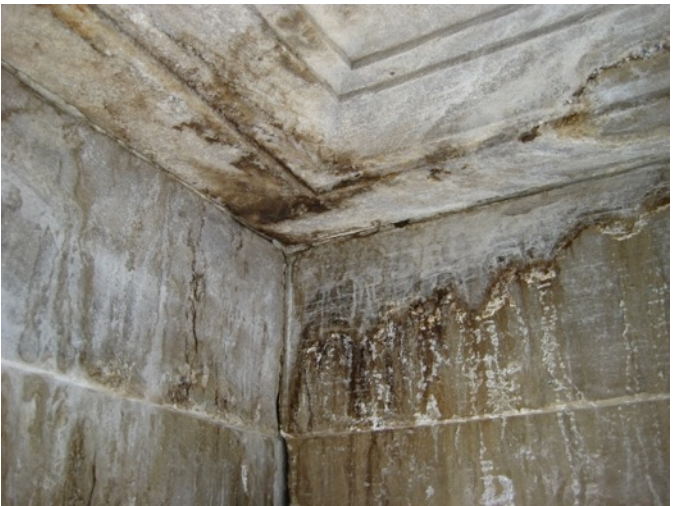
**Fig. 2.40: Staining & Erosion of Portico Clg.**

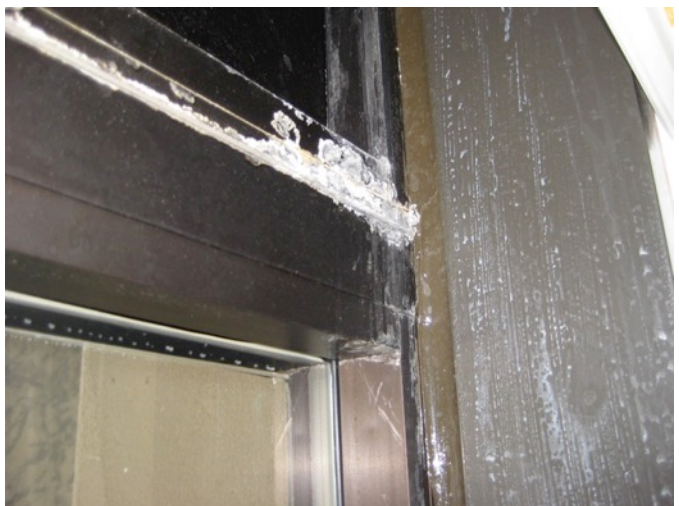
The infiltration at the portico also migrated down within the building's exterior wall, manifesting as leakage and lime staining at the windows within this portion of the building's wall, which was completely sheltered from direct rain contact by the portico.

**Fig. 2.42: Lime Staining Below Portico Roof**

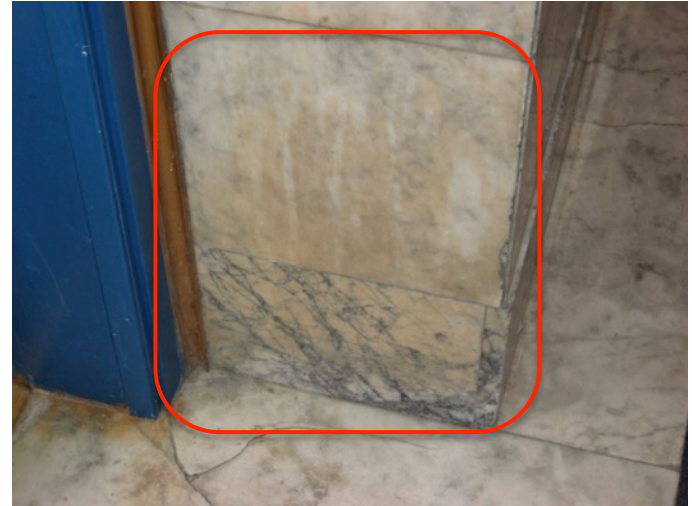
The infiltration even appeared to continue down to the ground level, manifesting as oxide staining on the interior marble wall cladding and highly elevated moisture readings. The oxide staining further implied that the steel wire anchorage of the structural stone pilasters, exceedingly minimal to begin with, was probably corroding.

**Fig. 2.44: Oxide Stains @ Interior Marble**

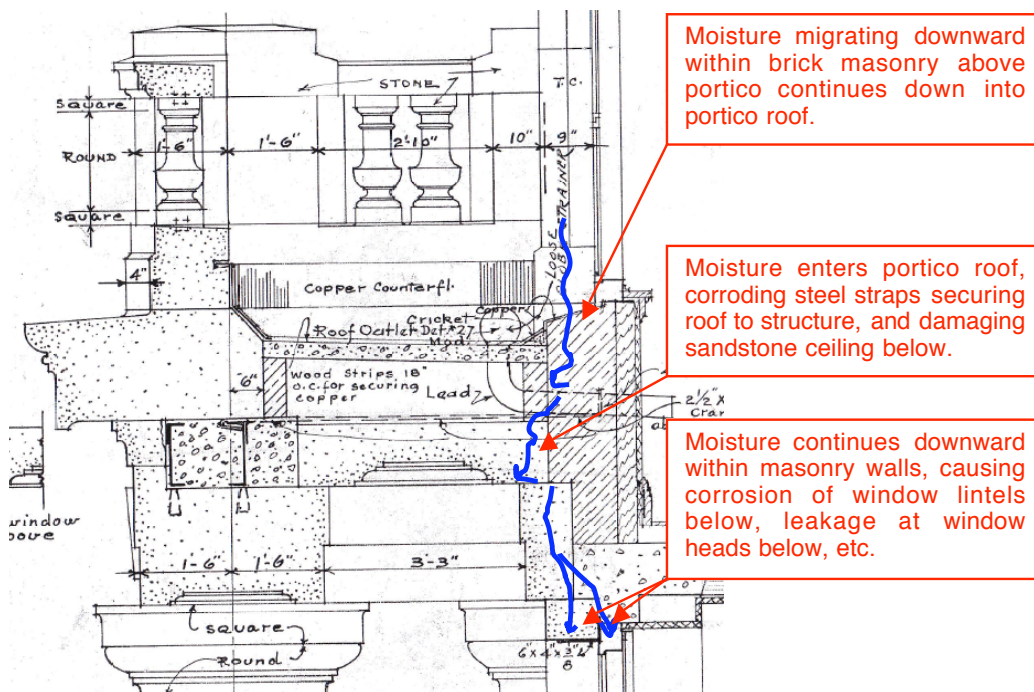
For example, the severe leakage plaguing the portico ceiling did not originate with its roof, but rather resulted from the downward migration of moisture within the building's multi-wythe exterior masonry walls above, which, reflecting construction methods of its time, did not incorporate through-wall flashings or weeps to capture and drain water back out of inherently absorbent masonry, and attempted to rely on the masonry thickness and mass to limit infiltration to the interior. While this "mass masonry" approach may suffice for many exterior detailing conditions in much drier climates, it has little chance against Juneau's 220 days of precipitation annually.

**Fig. 2.45: Infiltration Pathway Into Portico From Masonry Walls Above**

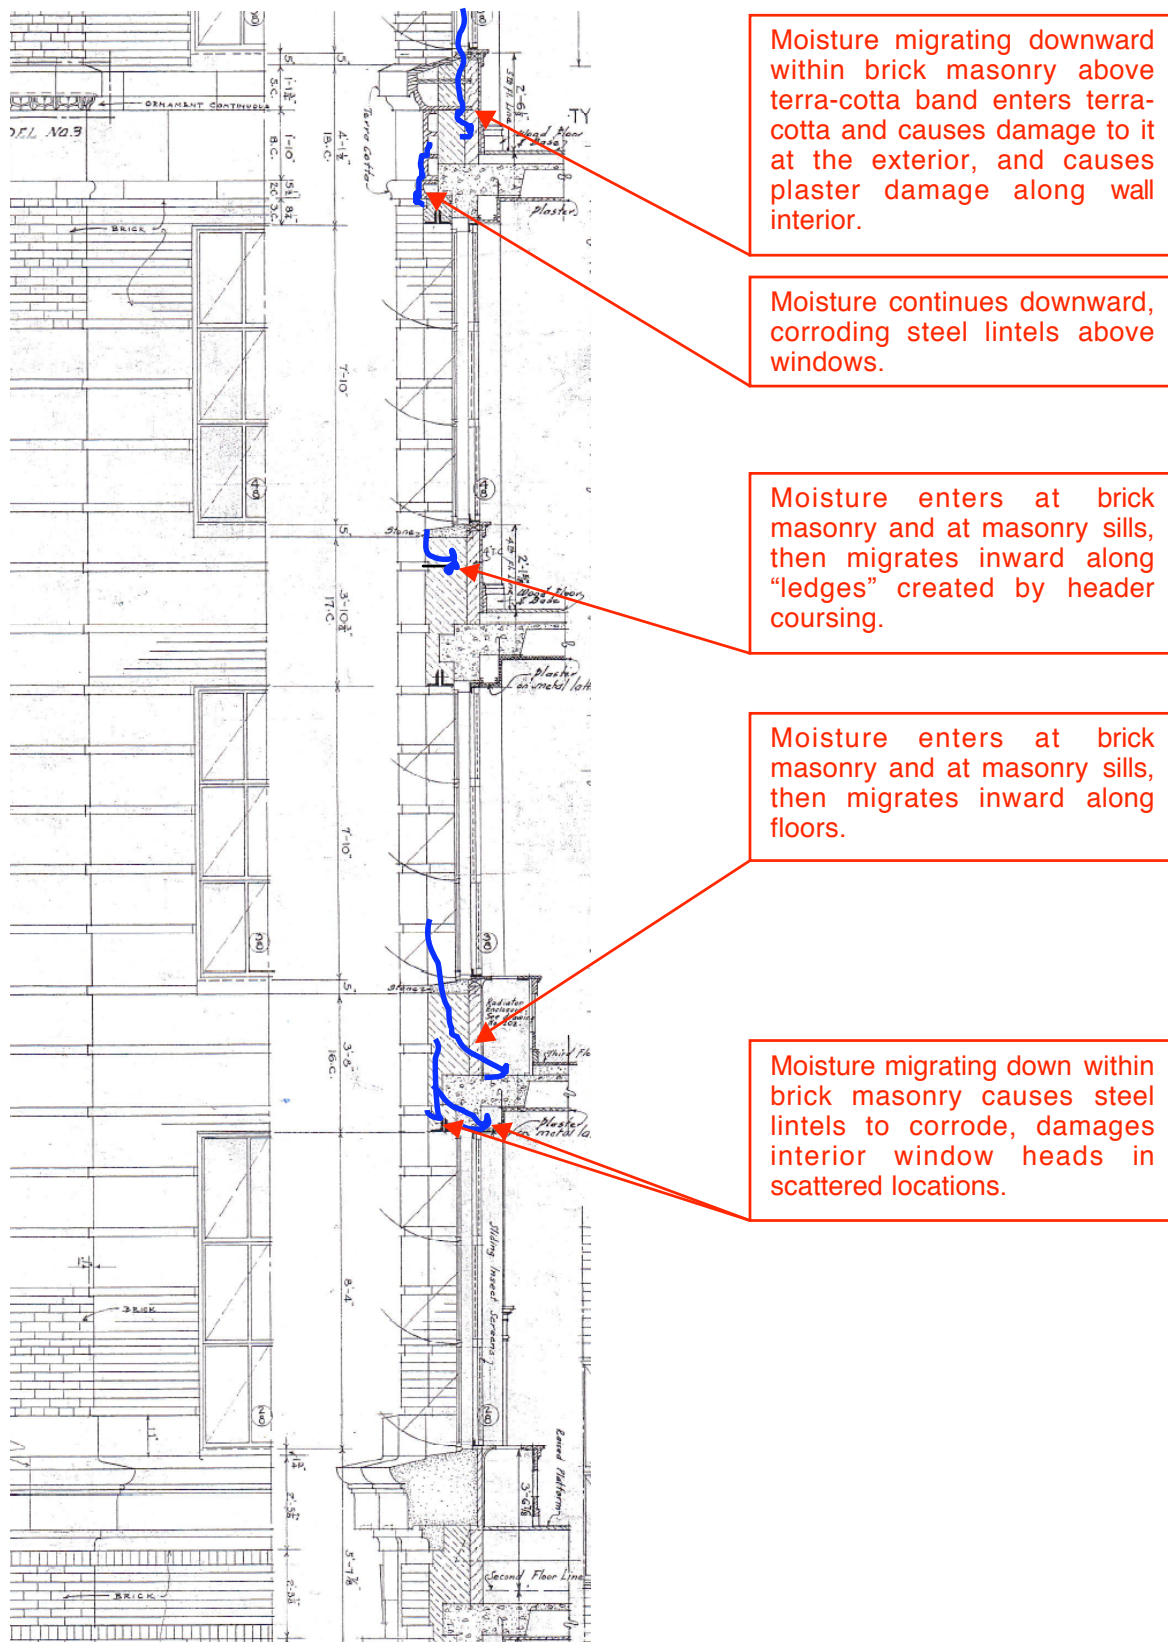
Masonry's inherent absorptivity, combined with this building's complete absence of through-wall flashings and Juneau's particularly wet climate affected all of the building's exterior walls, causing infiltration near many windows, corroding some steel lintels and anchors securing the terra-cotta elements, etc.

**Fig. 2.46: Infiltration Pathways Via Exterior Masonry Walls**

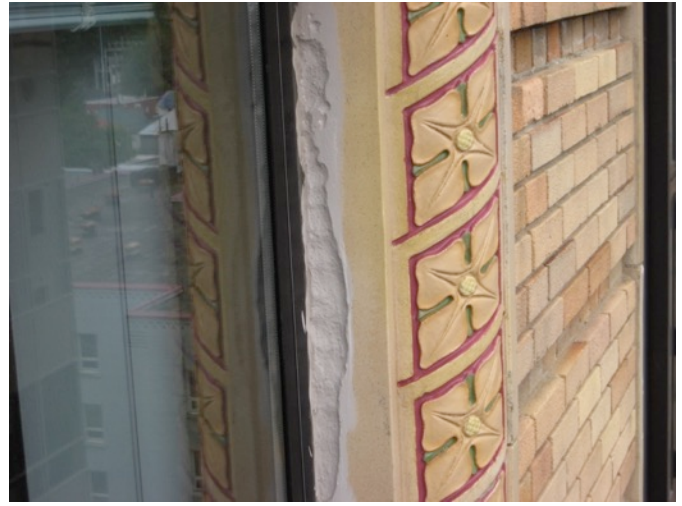
The multi-colored, ornate terra-cotta window surrounds were also experiencing freeze-spalling of variable degrees, though generally of lesser severity than at the projecting bands, due to their more weather-sheltered locations. In places, significant lime deposits had discolored these surrounds also.

**Fig. 3.24: Spalled T.-C. Window Surround**

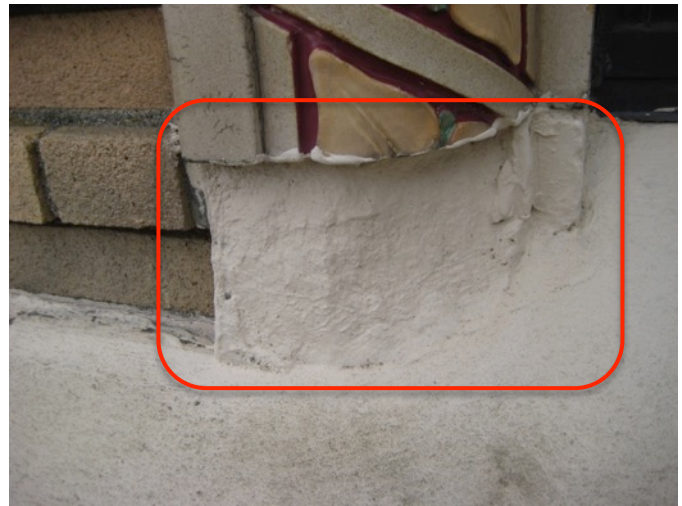
**Fig. 3.26: Spalled T.-C. Window Surround**

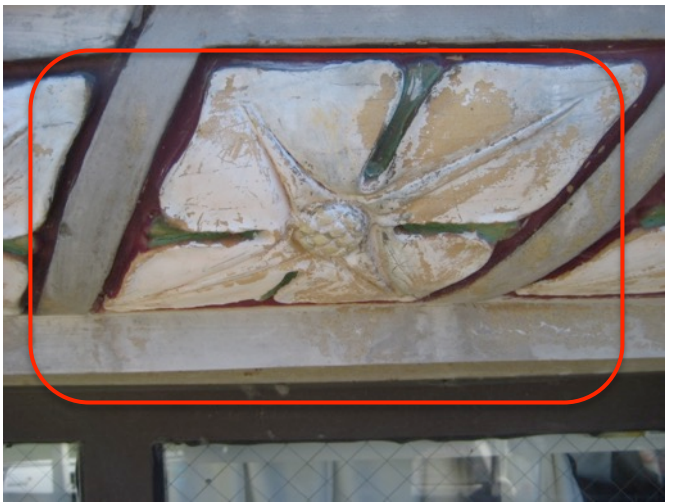
**Fig. 3.28: Lime-Stained Window Surround**

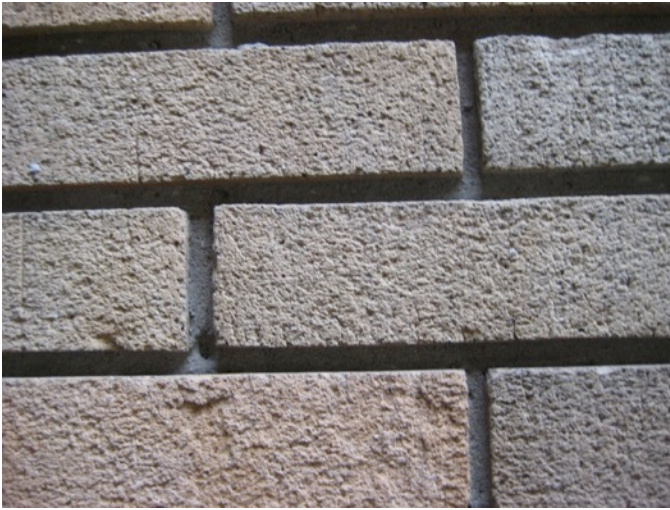
**Fig. 3.51: Spalled, Eroded Brick**

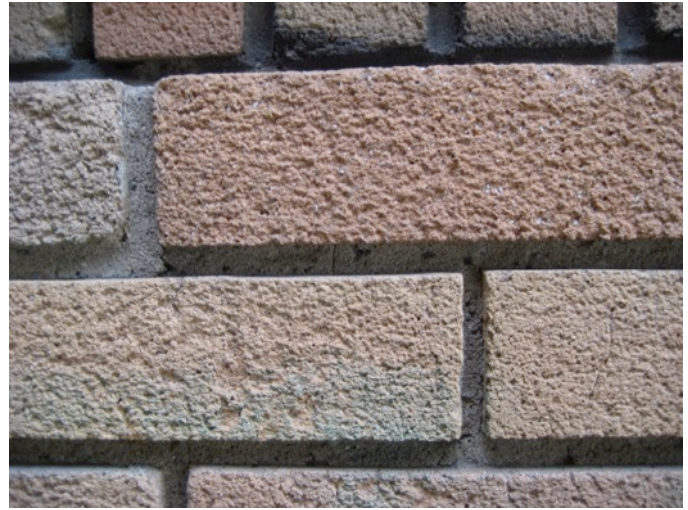
**Fig. 3.52: Eroded Brick**

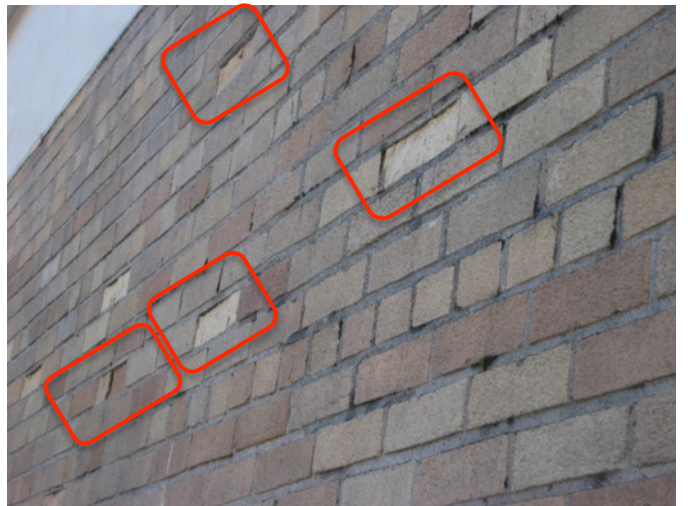
**Fig. 3.54: Spalled Brick**

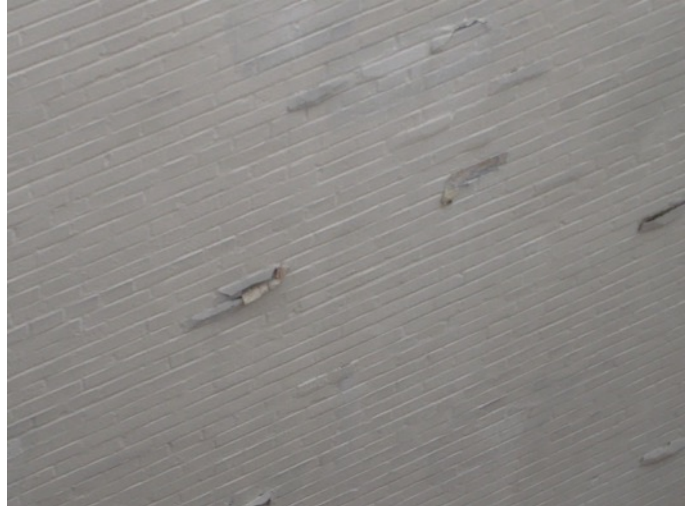
**Fig. 3.56: Spalled, Painted Brick**  
Note that brick was coated to limit leakage.

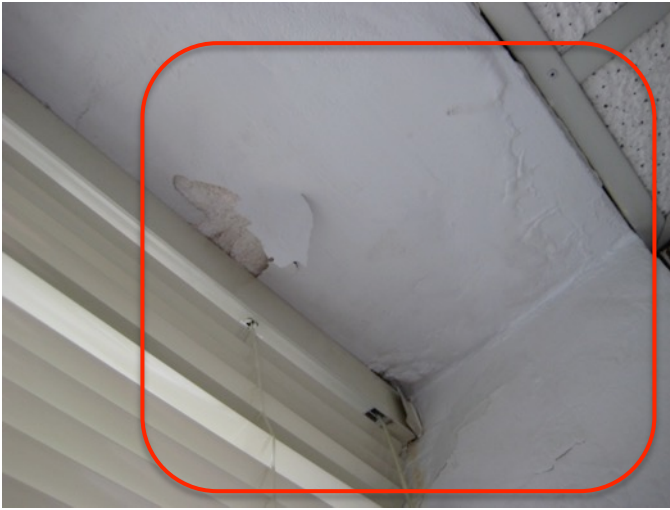
**Fig. 3.75: Plaster Damage Above Wind. Head**

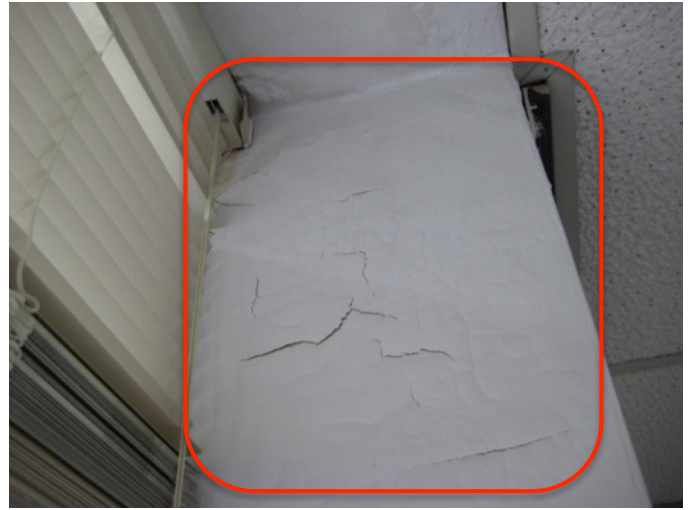
**Fig. 3.76: Plaster Damage on Jamb**

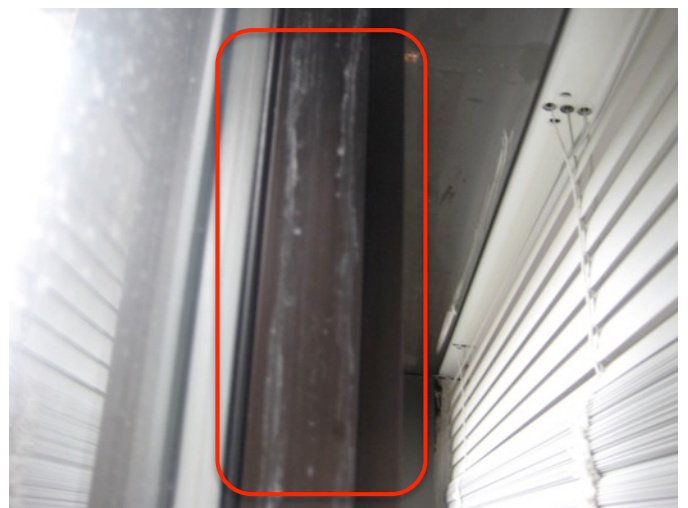
**Fig. 3.78: Lime Stains on Mullion**

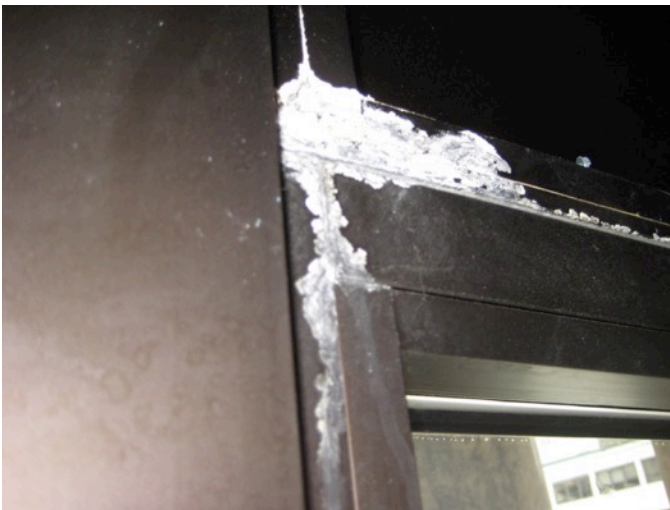
**Fig. 3.79: Lime Stains Exuding From Joints**

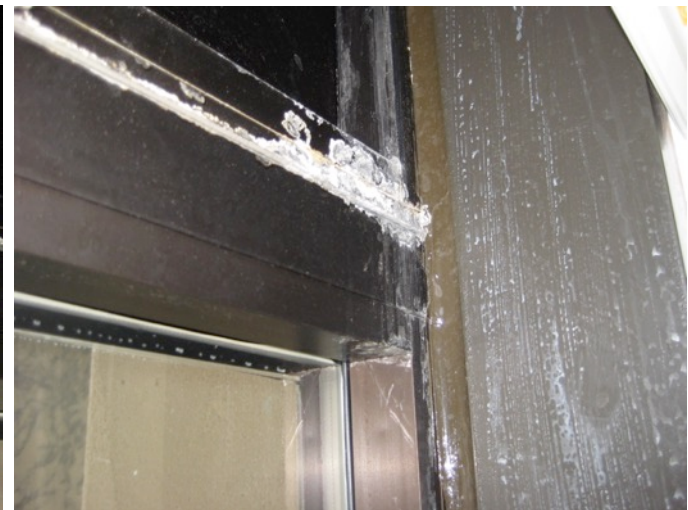
**Fig. 3.80: Lime Stains on Window Frame**

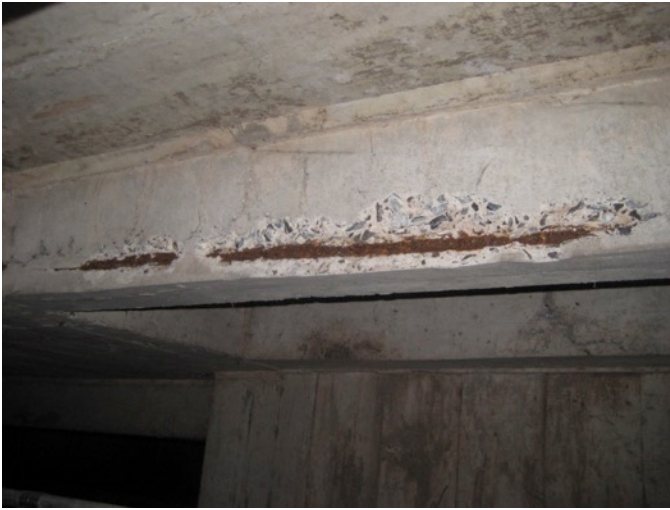
**Fig. 3.87: Corrosive Spalling of Fl. Joist**

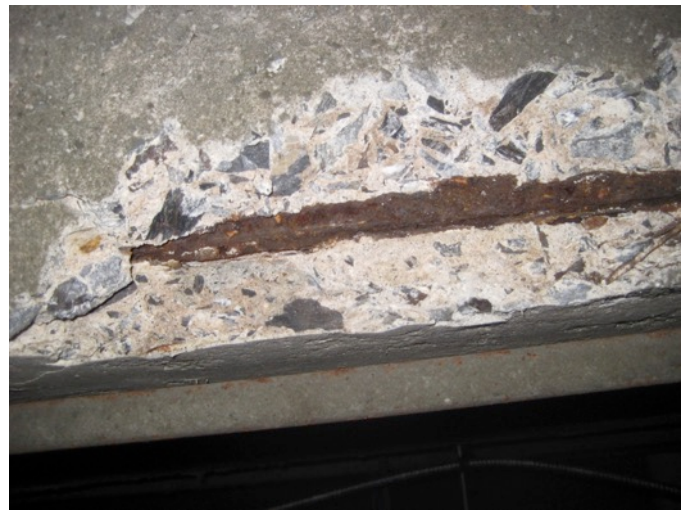
**Fig. 3.88: Corrosive Spalling of Fl. Joist**

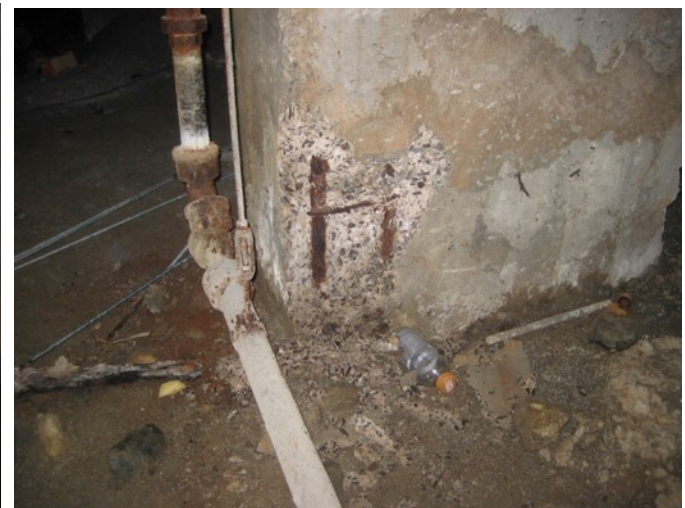
**Fig. 3.90: Corrosive Spalling of Pier**

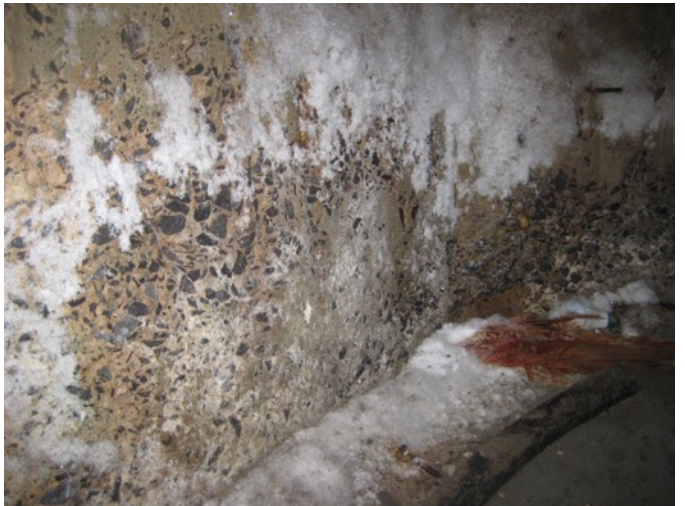
**Fig. 3.92: Efflorescence on Foundation Pier**

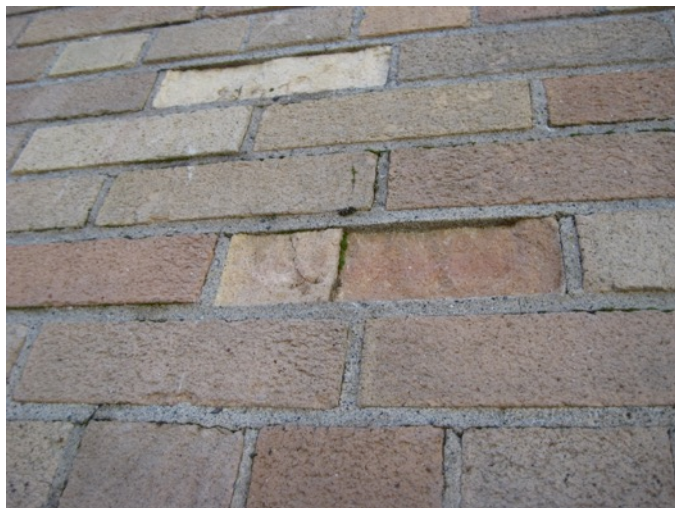
In the first, absorption of water, followed by freezing, induces the absorbed water to expand as it freezes within the masonry matrix, causing the outer faces to spall off. This freeze-spalling manifested on this building in most locations, reflecting Juneau's masonry-challenging climate. This is why the 1931 Alaska Capitol displayed so much more advanced degradation than a 1904 Seattle building, for while Seattle's 160 rainy days annually approach Juneau's 220-day rain frequency, its 23 yearly sub-freezing nights pale in comparison to Juneau's 150 days.

**Fig. 3.93: Spalled Brick on 1931 AK. Capitol, Fig. 3.94: Intact Brick on 1904 Seattle Bldg.**

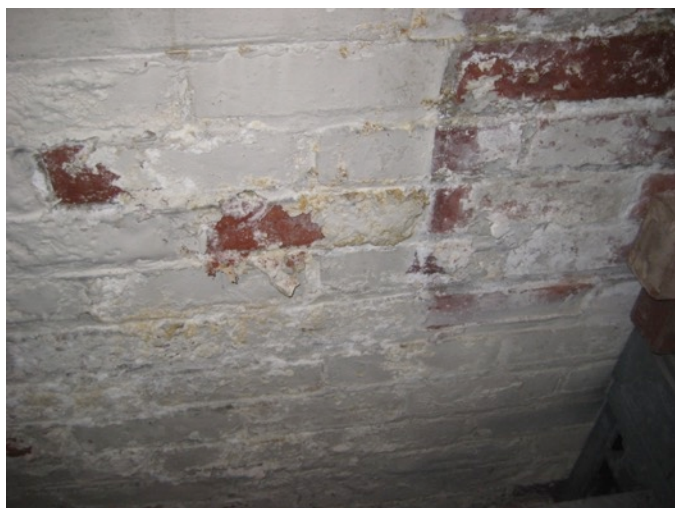
A second water-related masonry-damaging mechanism involves movement of water in one direction through masonry. On the capitol, such movement has been taking place since the building's construction, with rain water migrating inward through the brick walls. In doing so, this migrating water extracts salts from the masonry and carries these in solution toward the inner brick faces, where the water evaporates to the interior, leaving the salts near the innermost masonry face. As this process continues over decades, the concentration of salts near the inner masonry face becomes ever-greater, and much like water freezing, the crystallization of these salts within the masonry matrix causes expansion, leading to spalling and pulverization at the inner masonry faces. Where the inner face on this building could be examined, this inner-face phenomenon was also observed.

**Fig. 3.95: Spalling Interior Brick Face**
