# Re-Cladding the Alaska State Capitol: A Case Study in Rational Historic Preservation

## **Primary Team Members:**

Client:	State of Alaska, Legislative Affairs Agency
Architect:	Jensen Yorba Lott Inc.
Structural Engineer:	Swenson Say Faget Inc.
Building Envelope Consultant:	Paul Lukes: Building Envelope Consulting Services LLC.
Electrical Engineer:	Haight & Associates Inc.
Mechanical Engineer:	Murray & Associates P. C.
General Contractor, Portico:	Alaska Commercial Contractors
General Contractor, Building:	Dawson Construction Inc.

This article concerns the still ongoing re-clad and seismic upgrade of the Alaska State Capitol, scheduled for completion at the end of the 2016 construction season, a project I have been involved with over the course of 11 years.

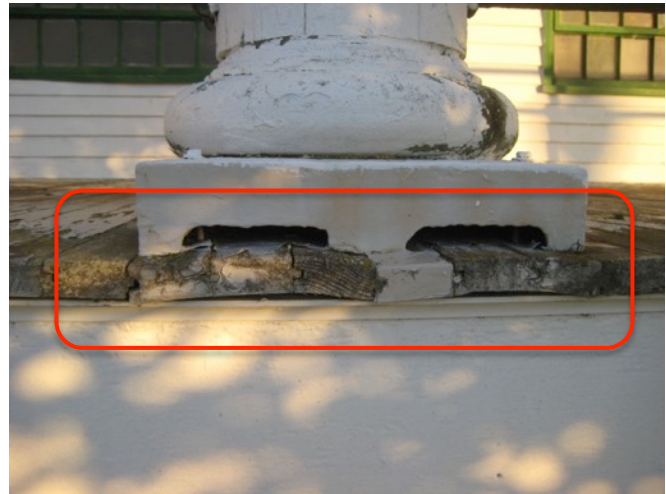
On another historic project, the original design placed decks of tightly-fitted tongue & groove decking, (T & G), in weather-exposed locations, with the predictable result of the wood decking buckling up and lifting column bases bearing on this decking, again due to cross-grain expansion of the wood in this location's wet climate. This was merely a technical error, one I suspect the original architect, given the chance to see the results, would opt to change. Yet, the preservation board insisted that this error, one relatively easily solved with very limited visible change, be duplicated exactly, dooming the new decks to the same failure mode within months of replacement.

### **Buckling Decking Under Columns Resulting From Cross-Grain Expansion**

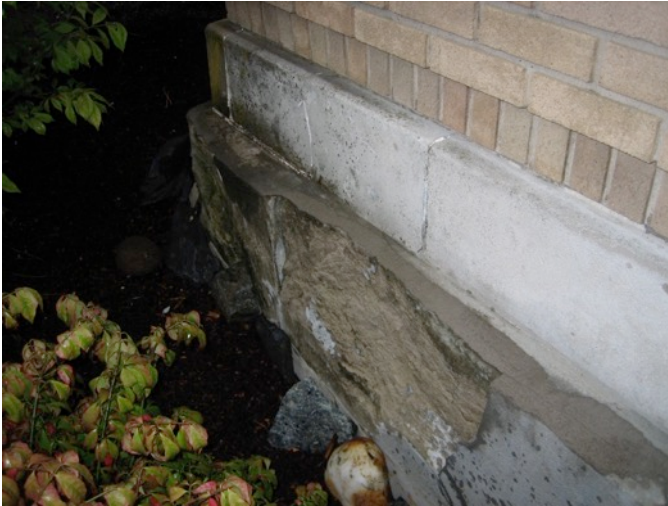
This examination revealed unexpectedly severe masonry degradation and cracking, relatively widespread leakage to the interior, spalling of the stone cladding resulting from anchor corrosion, among many other symptoms. The brick itself appeared very rough as if sandblasted, and contained various cracks, some extending over 10 feet. In short, the building's exterior masonry was in rather poor condition, particularly in view of the building's relatively young age.

**Fig. 1.1: Degradation of Stone Base**

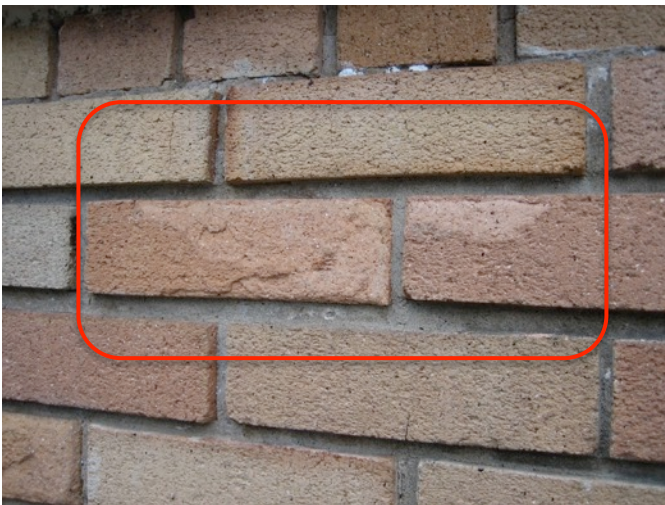
**Fig. 1.3: Brick Spalling**

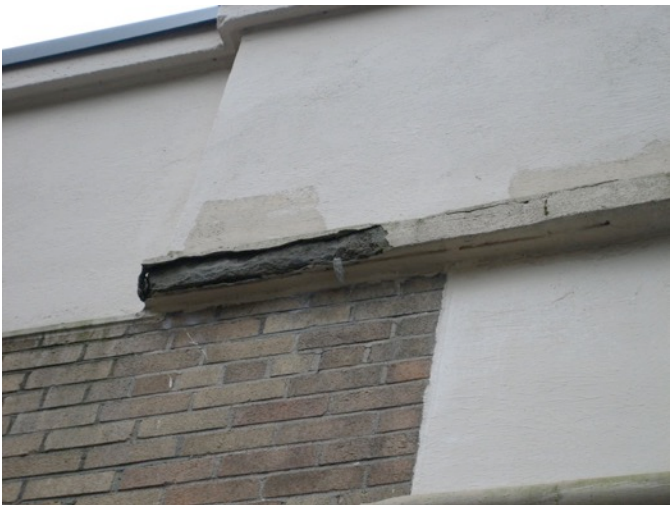
**Fig. 1.9: Spalling Stone Cornice Band**

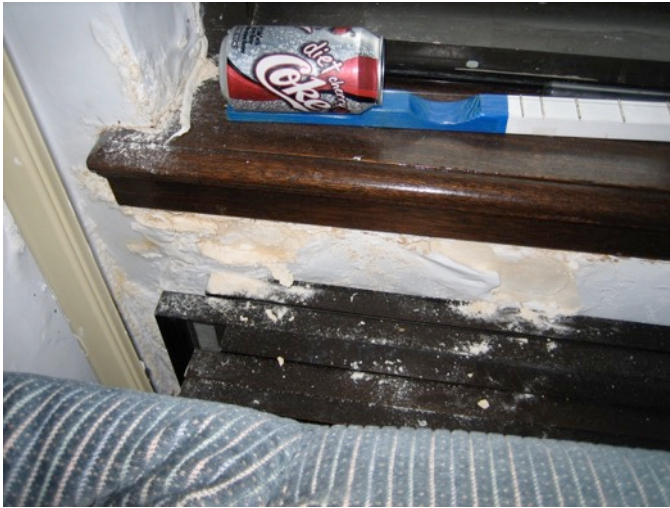
**Fig. 1.11: Water Infiltration to Interior**

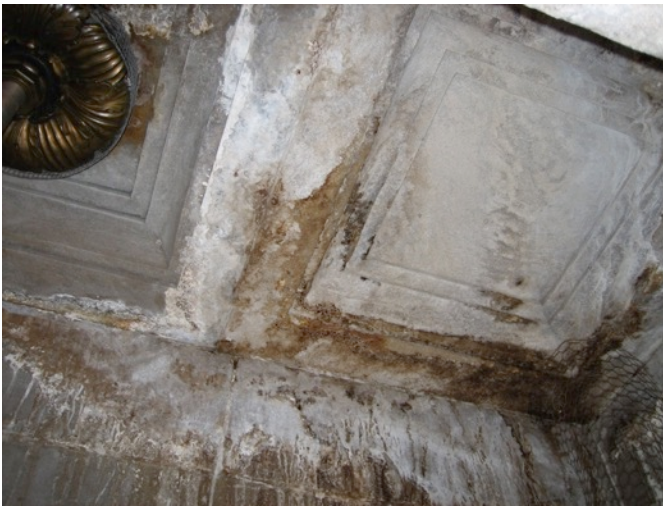
**Fig. 1.13: Water Infiltration Into Portico Clg.**

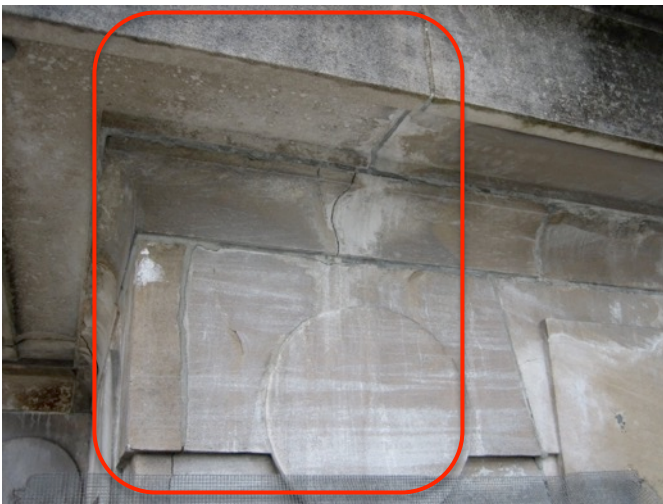
Further, the stone entry portico appeared to suffer both severe water infiltration and associated damage as well as seemingly dangerous cracking of stone beams supporting the portico's roof.

**Fig. 1.15: Cracking of Stone Portico Beams**

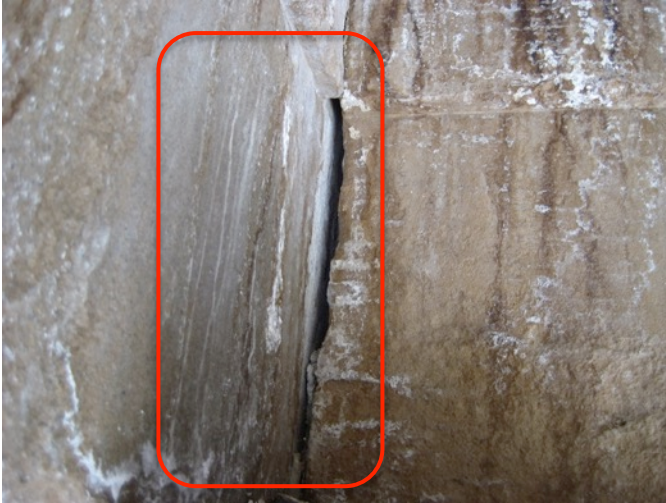
This confirmed my earlier concerns about the portico, whose multi-ton stone structural beams and adjacent window headers were seriously cracked, seemingly vulnerable to collapse in a seismic event. Double-fist sized chunks of stone had already spalled off in the past, apparently from seismic events, onto the granite floor of the entry below.

**Fig. 2.1: Separation of Stone Beams**

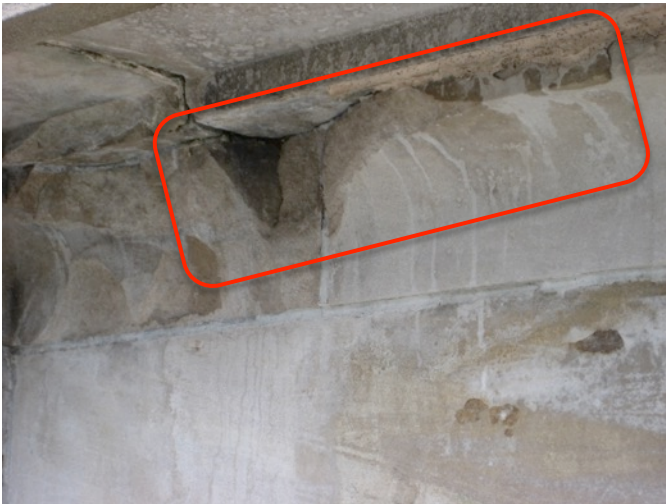
**Fig. 2.3: Spalled-Off Chunk of Stone**

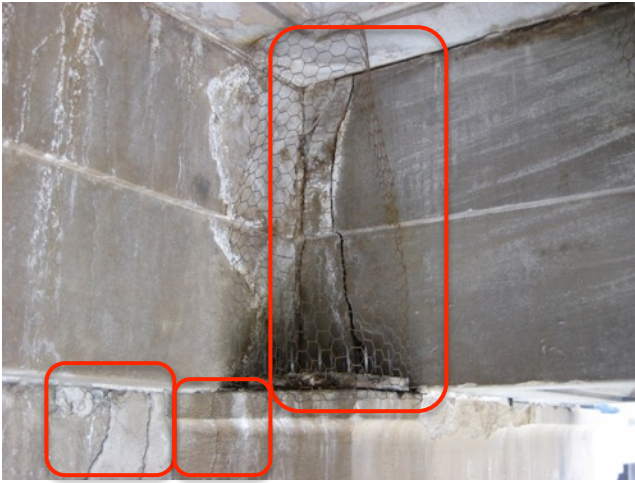
**Fig. 2.5: Cracked Stone Beam & Header**

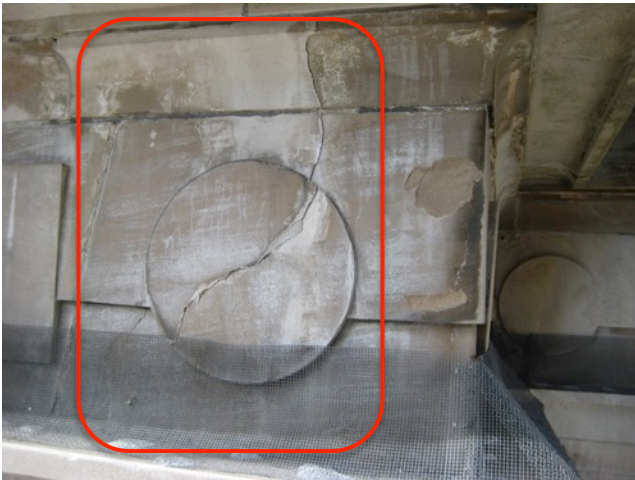
**Fig. 2.7: Cracked Stone Beam End**

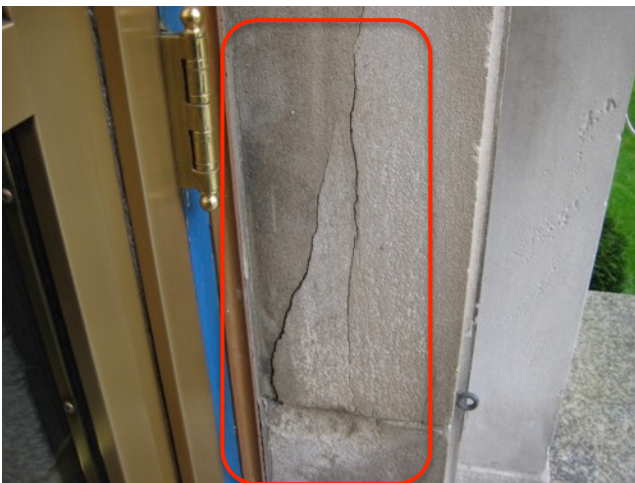
My concern with the seemingly significant cracking of the stone portico beams was only exacerbated by the vertical cracking in the bottoms of the stone pilasters which actually provided the structural support for the cracked beams above. The constellation of these symptoms implied exactly the type of twisting motion this portico would be expected to experience in an earthquake. I saw no prior mention of any observed damage following earthquakes, though some of the damage was readily apparent.

**Fig. 2.9: Cracked Middle of Struct. Pilstr.**

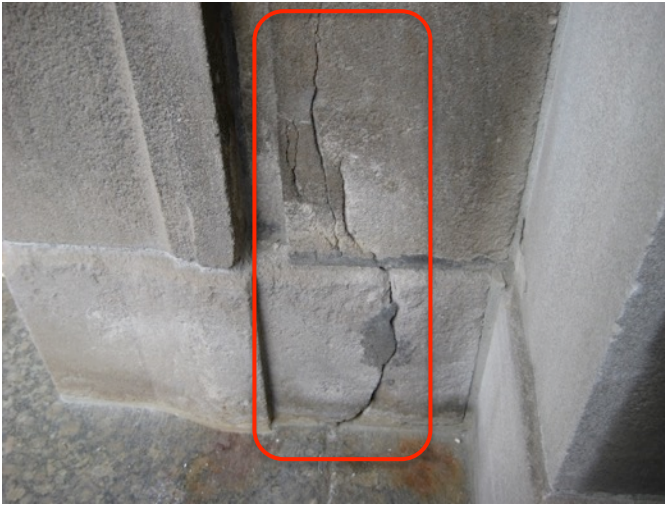
**Fig. 2.11: Cracked Base of Struct. Pilaster**

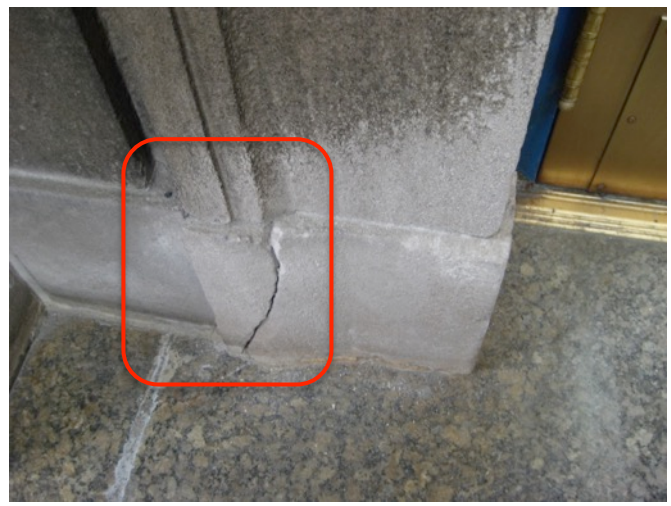
**Fig. 2.12: Cracked Base of Struct. Pilaster**

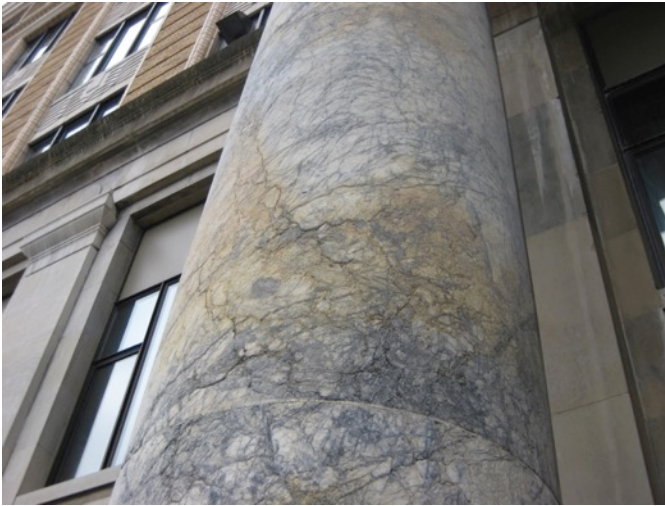
The four marble columns supporting the portico themselves displayed not only serious surface weathering and oxide staining, but also some possibly deep cracking, and while absorption testing indicated these columns to be generally well-sealed, extremely high absorption at even the tiniest of these cracks implied that these fissures may be deep and extensive. Similarly, the granite portico base beneath these columns and abutting stairs showed differential displacement of up to  $\frac{3}{4}$ " in places, revealing significant movement in the past. Per the original construction drawings, the three 8-foot tall, 3-foot wide marble sections, each weighing roughly 13,000 pounds, comprising each column were interconnected only with short "cube dowels" at their joints, making the columns little more than loosely-stacked stones, exacerbating seismic concerns.

**Fig. 2.15: Staining, Cracking at Portico Col.**

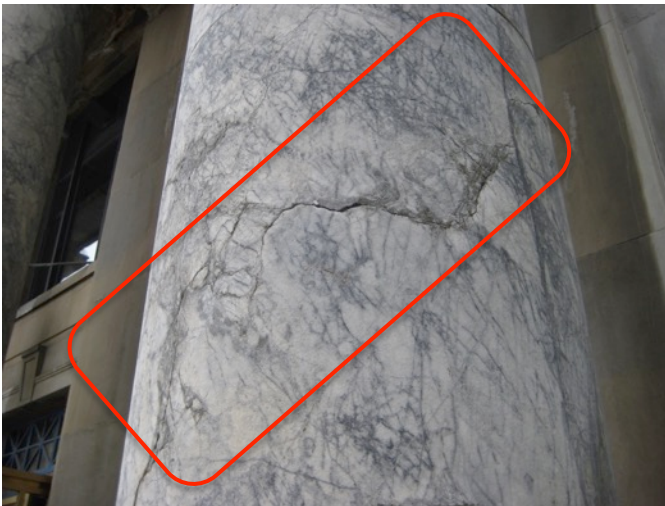
**Fig. 2.17: Cracking at Portico Column**

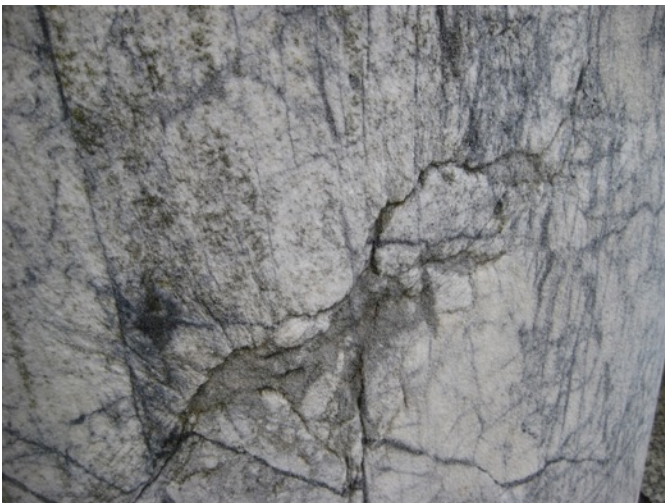
**Fig. 2.19: Cracking at Portico Column**

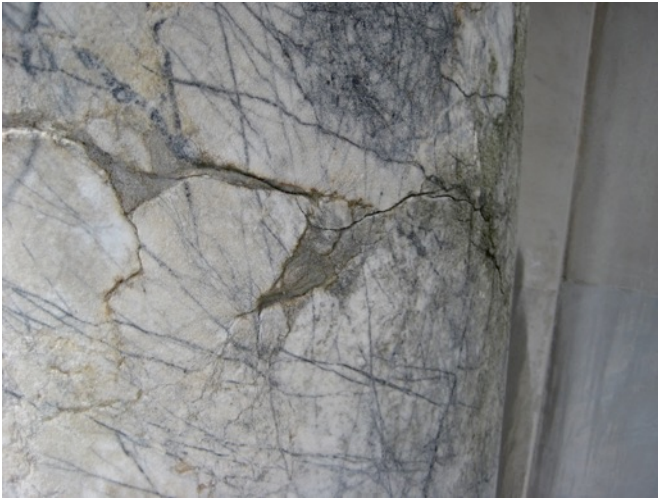
**Fig. 2.21: Cracking at Portico Column**

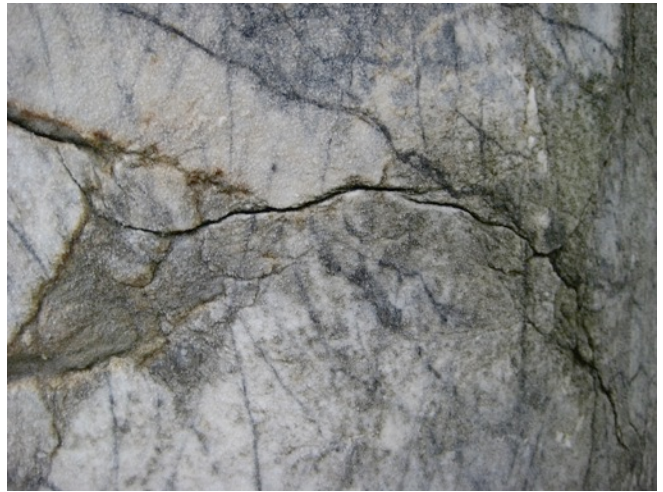
**Fig. 2.22: Cracking at Portico Column**

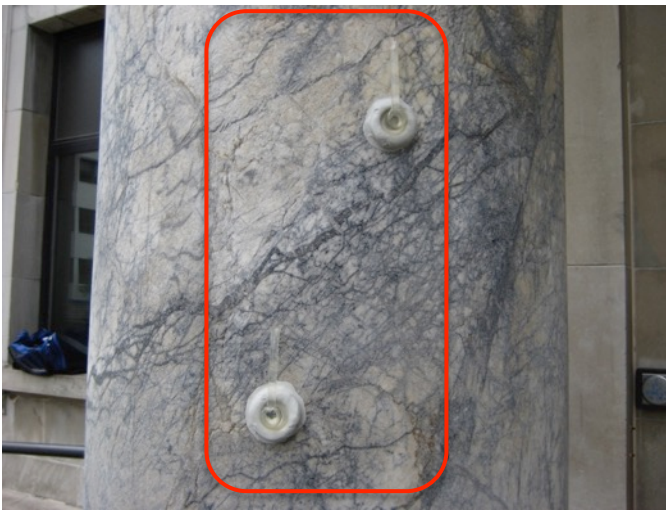
**Fig. 2.23: RILEM Absorption Testing of Col.**

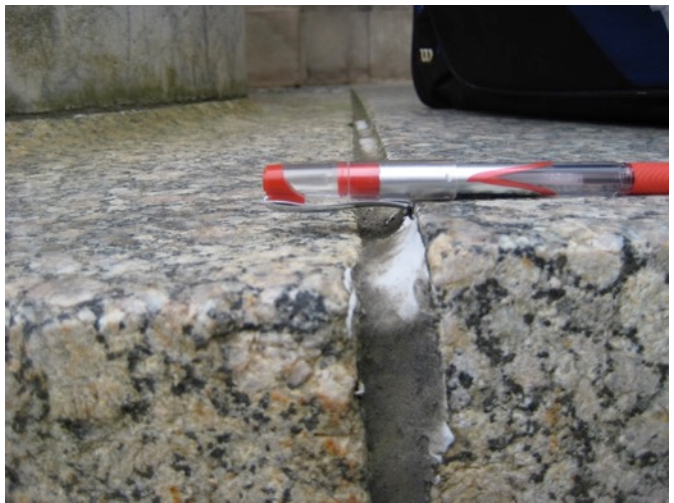
**Fig. 2.24: Downward Displacement Bel. Col.**

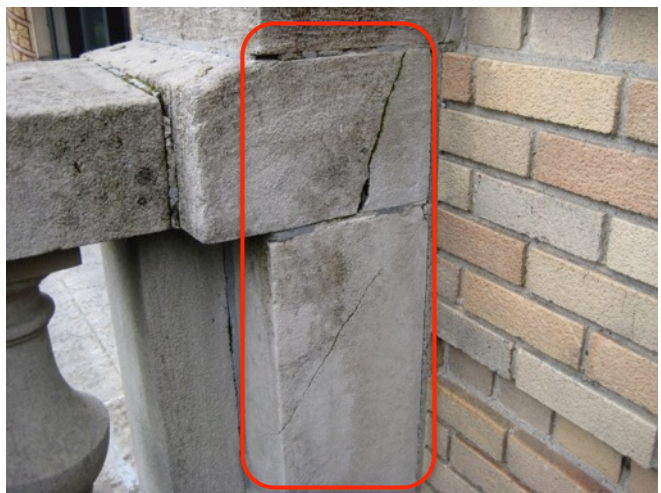
The portico's limestone railing elements also displayed cracking and displacement, and I was able to push some 200 pound stone caps from their positions, indicating that these had not been connected to the structure in any way other than mortar, which had cracked apart decades earlier.

**Fig. 2.29: Cracking in Portico Railing**

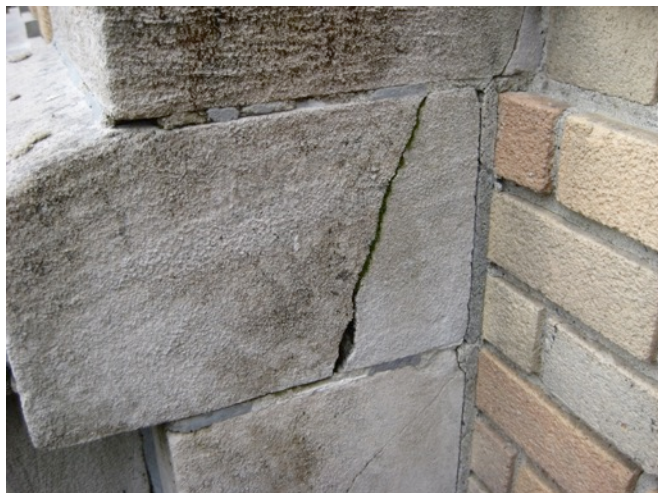
**Fig. 2.30: Cracking at Portico Railing**

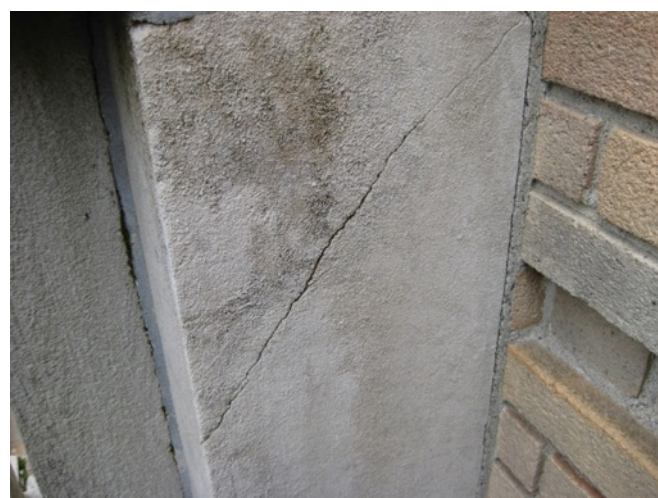
**Fig. 2.32: Cracking at Portico Railing**

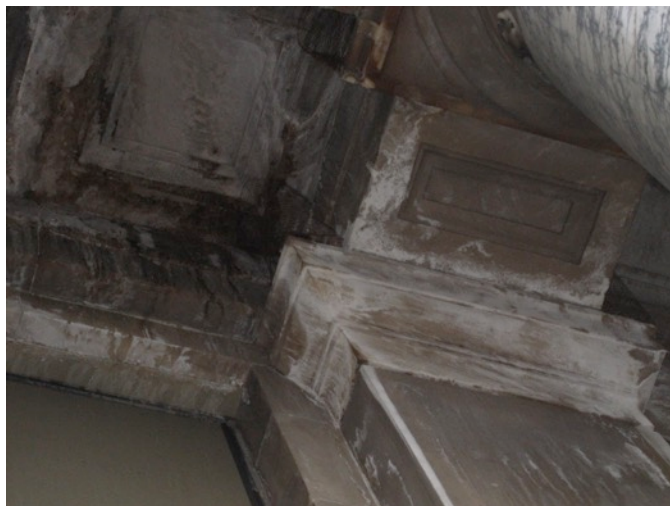
Further, it was clear from the severely stained, in places eroded stone ceilings that water had been seeping down through the portico deck structure since its original construction, causing 80 years of water damage and probable corrosion of reinforcing steel embedded within the portico's concrete deck and beams.

**Fig. 2.35: Severe Staining of Portico Ceiling**

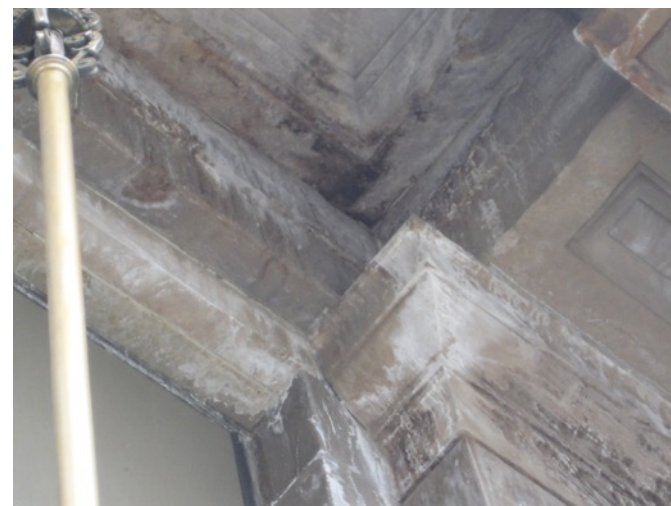
**Fig. 2.36: Severe Staining of Portico Ceiling**

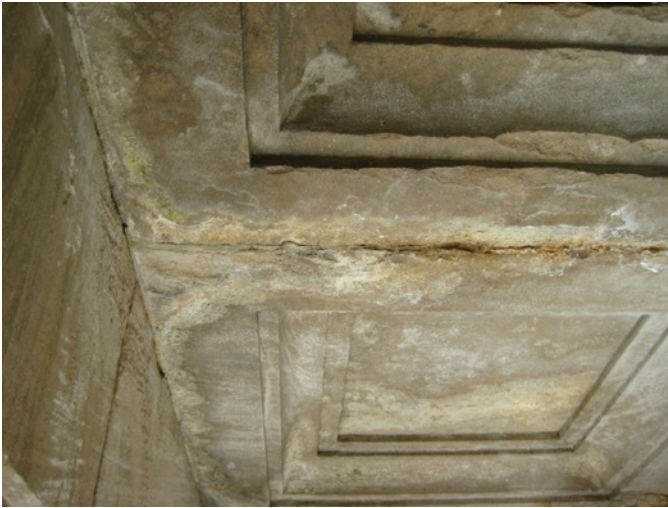
**Fig. 2.37: Staining & Erosion of Portico Clg.**

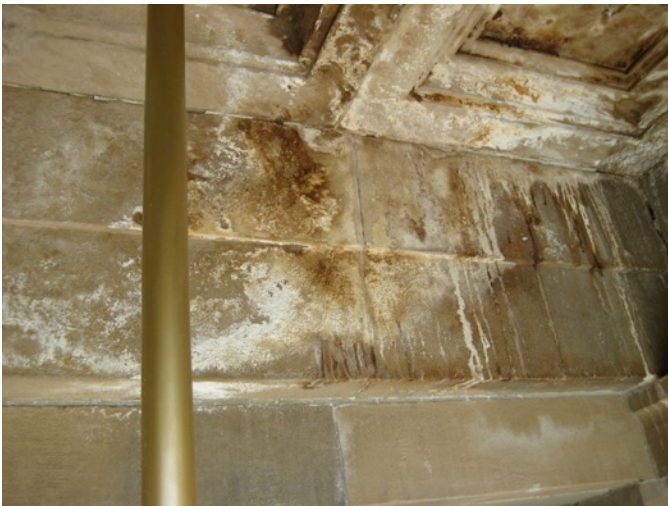
**Fig. 2.39: Staining & Erosion of Portico Clg.**

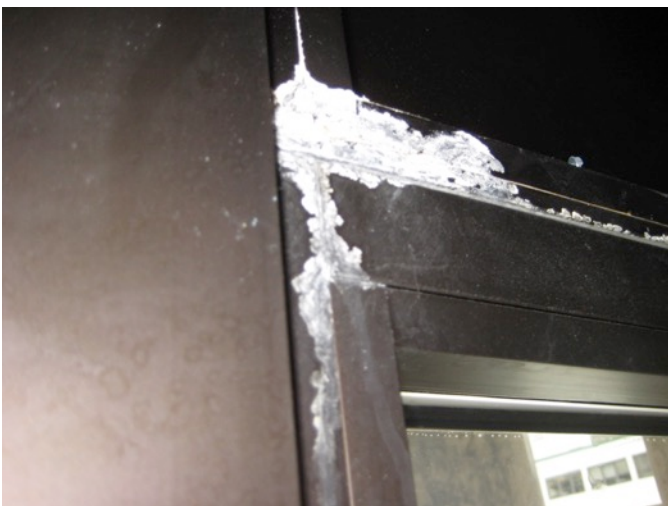
The infiltration at the portico also migrated down within the building's exterior wall, manifesting as leakage and lime staining at the windows within this portion of the building's wall, which was completely sheltered from direct rain contact by the portico.

**Fig. 2.41: Lime Stains @ Window Bel. Port.**

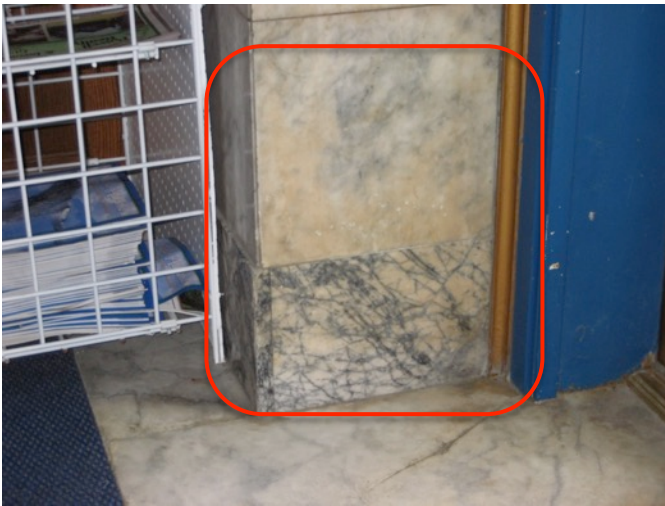
The infiltration even appeared to continue down to the ground level, manifesting as oxide staining on the interior marble wall cladding and highly elevated moisture readings. The oxide staining further implied that the steel wire anchorage of the structural stone pilasters, exceedingly minimal to begin with, was probably corroding.

**Fig. 2.43: Oxide Stains @ Interior Marble**

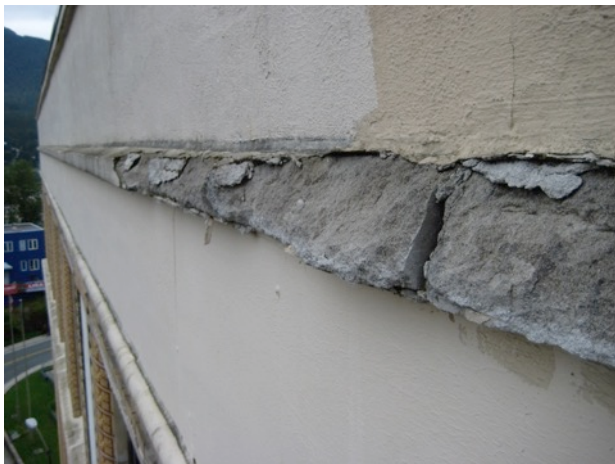
For example, starting at the building's top, the roof-level masonry band which replaced the original cornice was spalling extensively, in particular along a projecting narrow band, posing appreciable risk to pedestrians below.

**Fig. 3.1: Spalling Roof-Level Band**

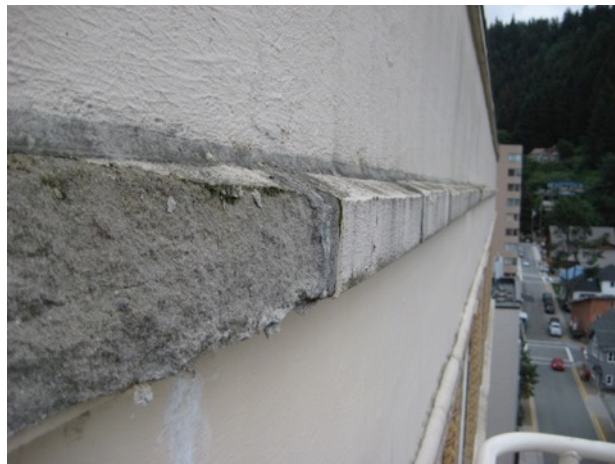
**Fig. 3.2: Spalling Roof-Level Band**

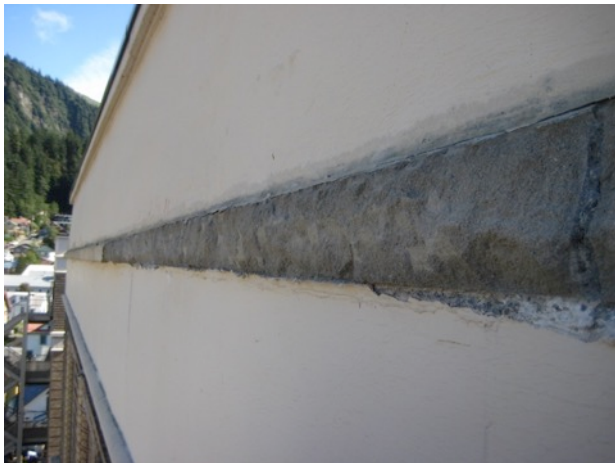
**Fig. 3.3: Spalling Roof-Level Band**

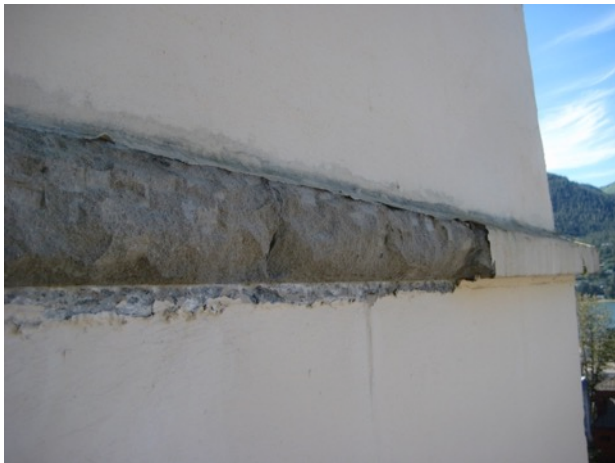
**Fig. 3.4: Spalling Roof-Level Band**

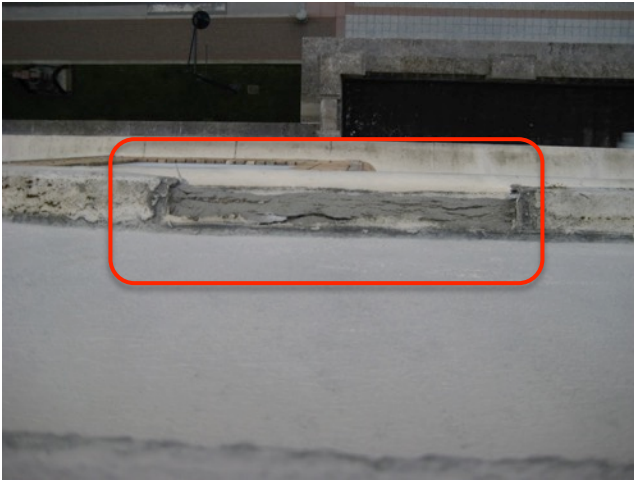
**Fig. 3.5: Spalling Roof-Level Band**  
Note “ready-to-fall” piece.

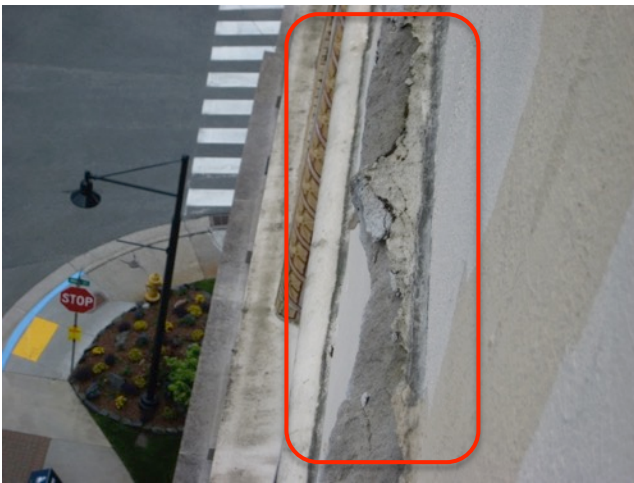
**Fig. 3.7: Spalling Roof-Level Band**  
Note sidewalks below.

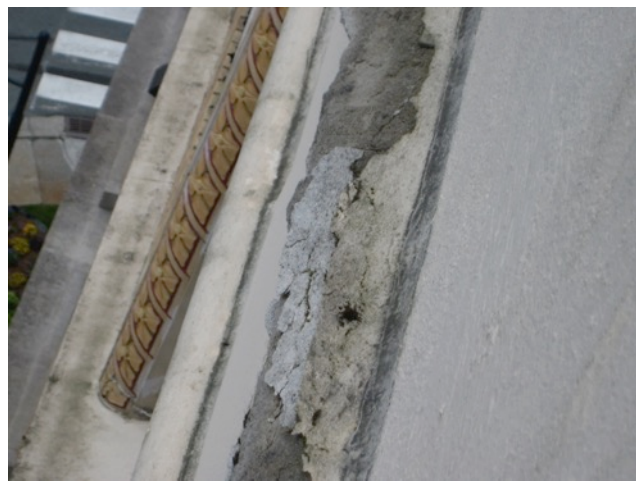
**Fig. 3.8: Spalling Roof-Level Band**  
Note sidewalks below.

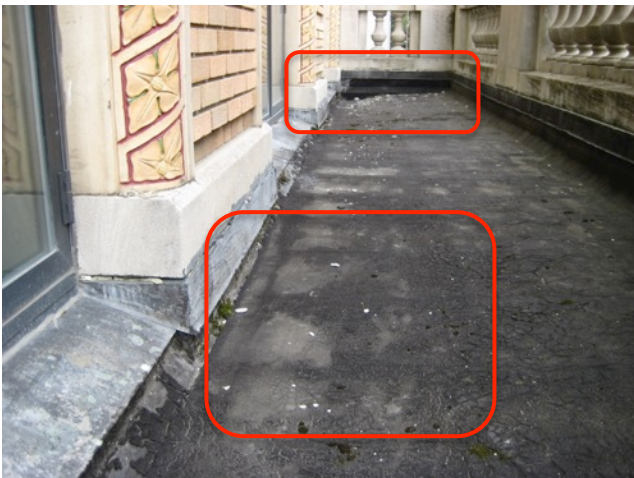
The potential risk to pedestrians below was readily illustrated by the accumulation of stone chunks of varying sizes atop the portico roof, which was cleaned less frequently than the sidewalks. In fact, I happened to be atop the main roof, looking down onto the portico, when a fist-sized chunk fell and shattered on the portico roof 55 feet below.

**Fig. 3.9: Spalled-Off Pieces on Portico**

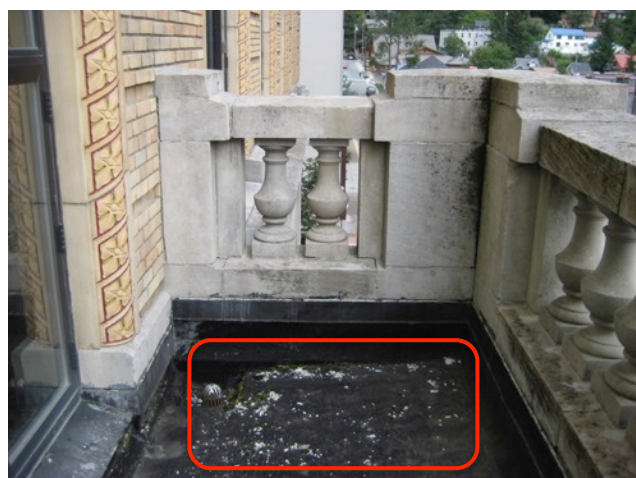
**Fig. 3.10: Spalled-Off Pieces on Portico Roof**

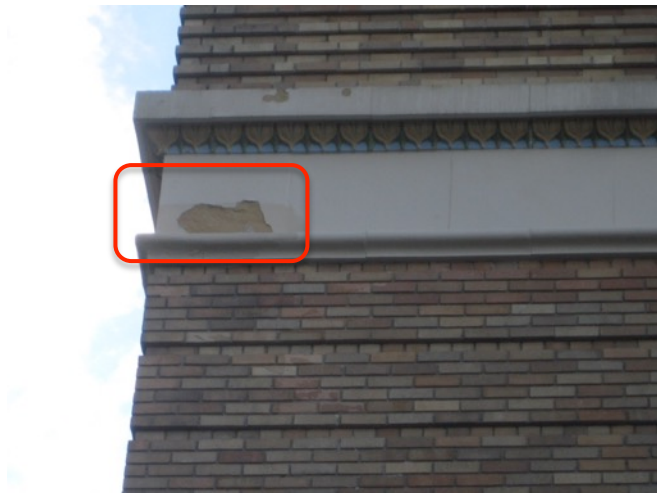
Similarly, the building's level 5 terra-cotta water-table was experiencing in-places severe freeze-spalling, and scattered locations of reddish oxide staining oozing from cracks in the terra-cotta implied that embedded steel anchors were corroding.

**Fig. 3.11: Spalling Level 5 T.-C. Band**

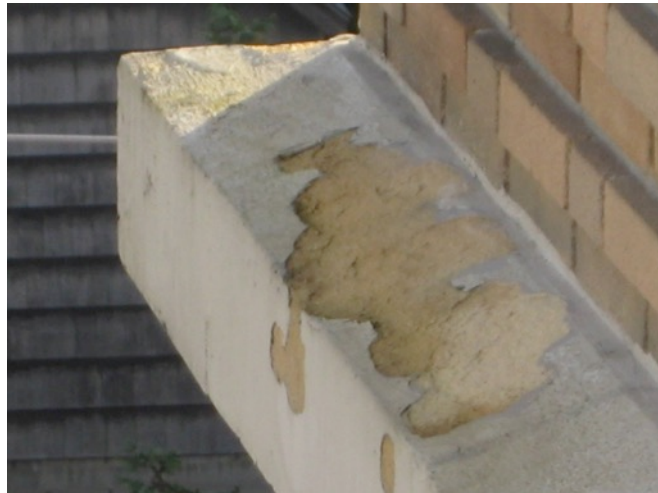
**Fig. 3.12: Spalling Level 5 Terra-Cotta Band**

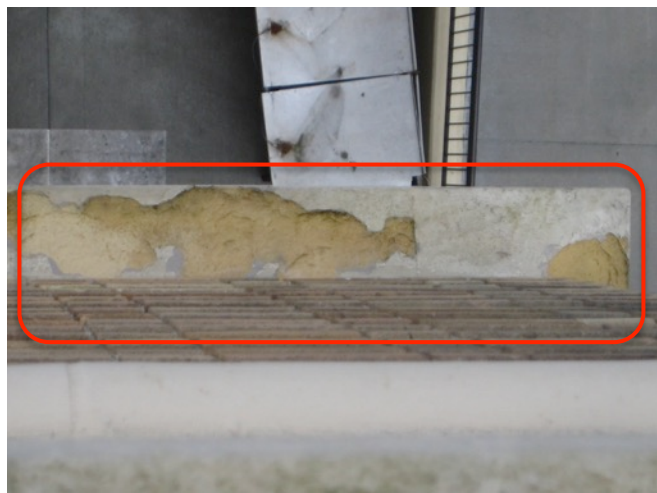
**Fig. 3.13: Spalling Level 5 Terra-Cotta Band**

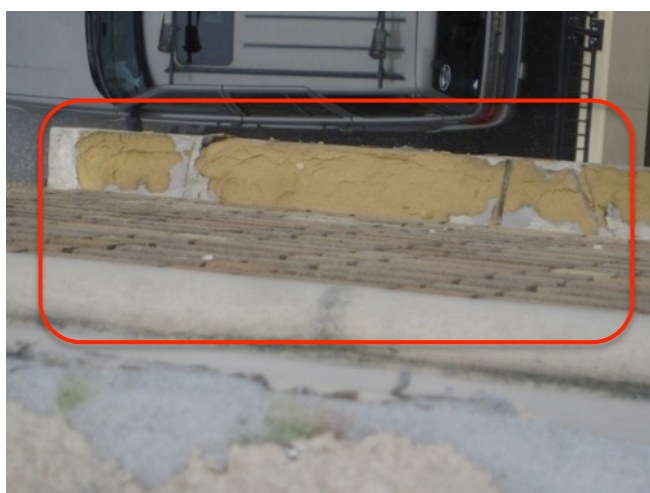
**Fig. 3.14: Spalling Level 5 Terra-Cotta Band**

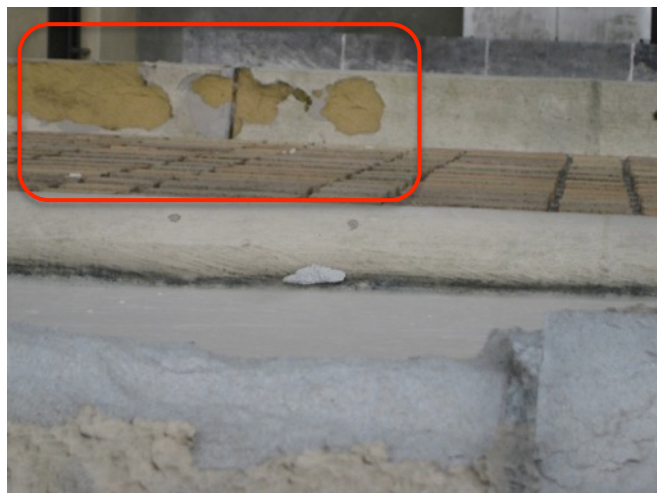
**Fig. 3.15: Spalling Level 5 Terra-Cotta Band**

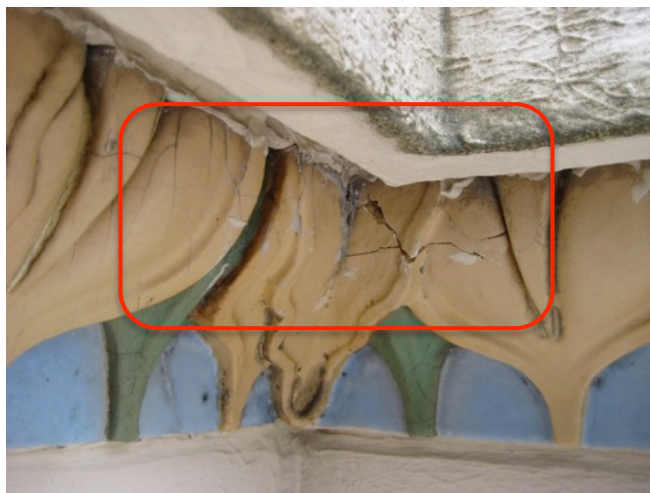
**Fig. 3.16: Cracking Level 5 Terra-Cotta Band**

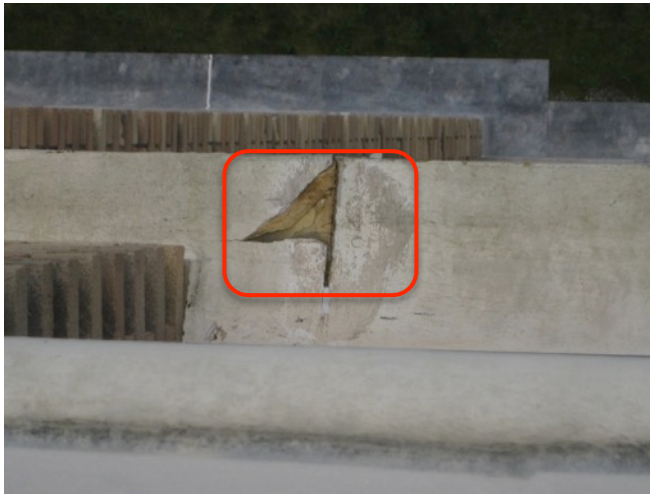
**Fig. 3.17: Spalling Level 5 Terra-Cotta Band**

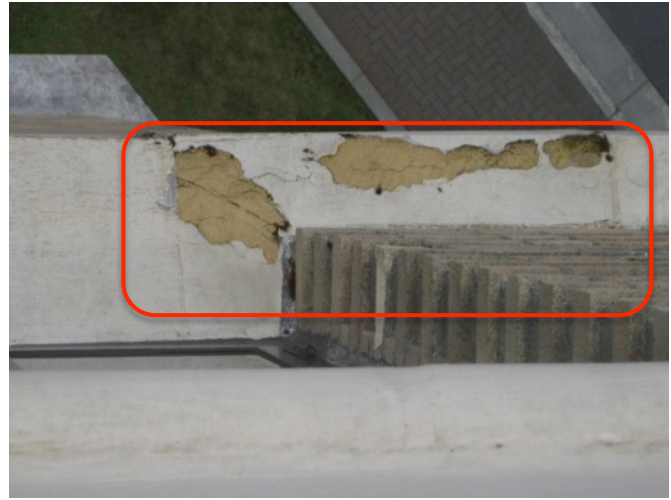
**Fig. 3.18: Spalling Level 5 Terra-Cotta Band**

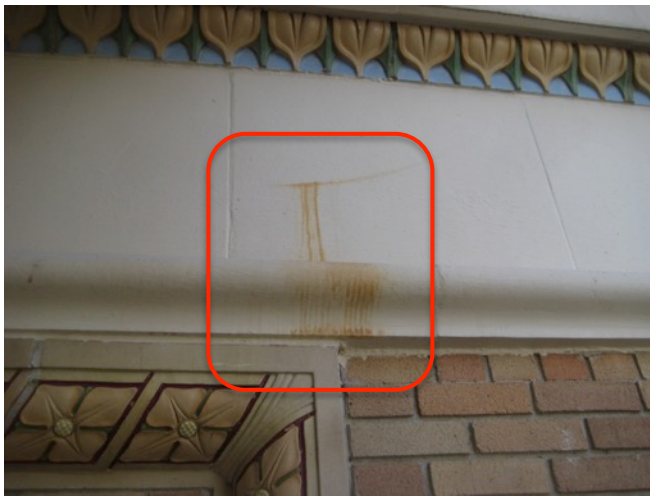
**Fig. 3.19: Oozing Oxide Stain @ Lev. 5 T.-C.**

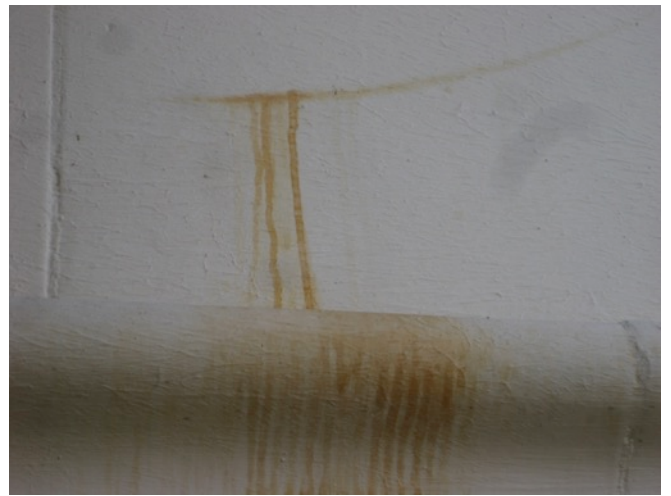
**Fig. 3.20: Close-Up of Oxide Stain @ T.-C.**

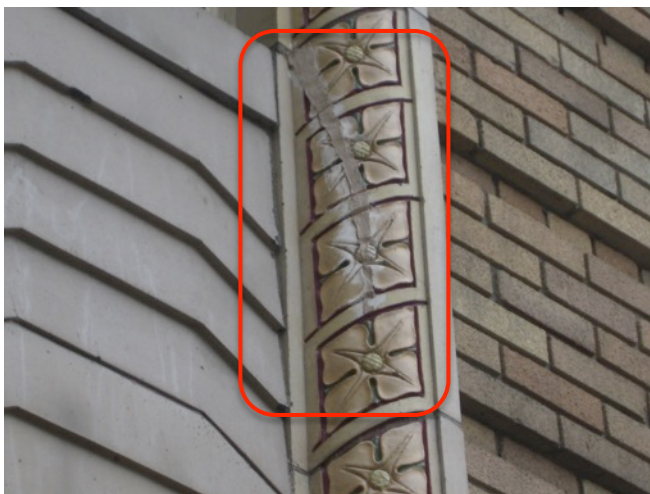
The multi-colored, ornate terra-cotta window surrounds were also experiencing freeze-spalling of variable degrees, though generally of lesser severity than at the projecting bands, due to their more weather-sheltered locations. In places, significant lime deposits had discolored these surrounds also.

**Fig. 3.21: Spalled T.-C. Window Surround**

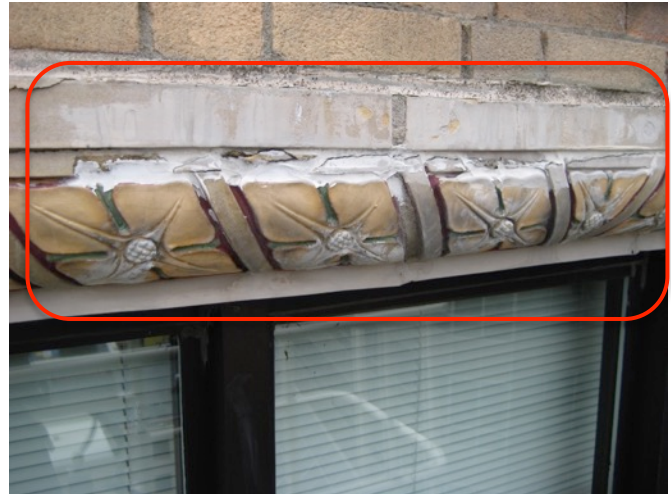
**Fig. 3.22: Spalled T.-C. Window Surround**

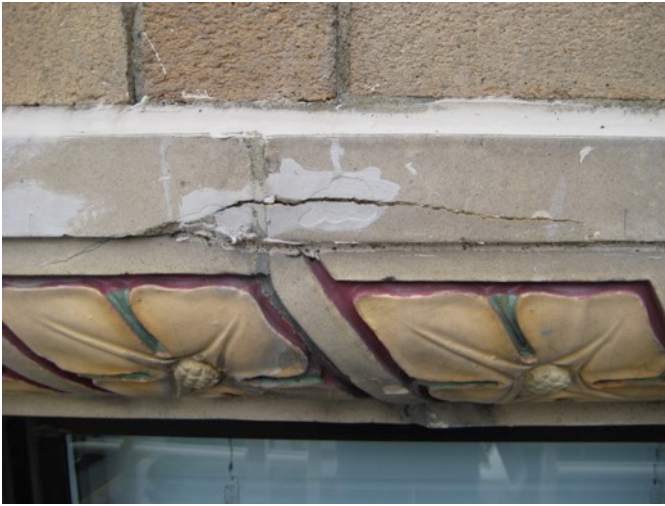
**Fig. 3.23: Spalled T.-C. Window Surround**

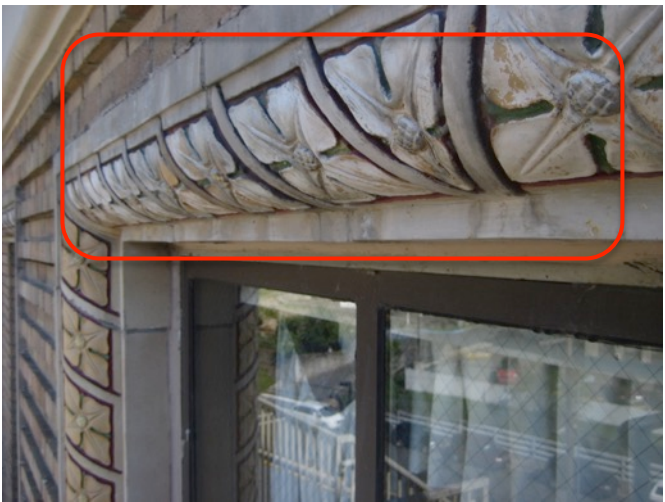
**Fig. 3.27: Lime-Stained Window Surround**

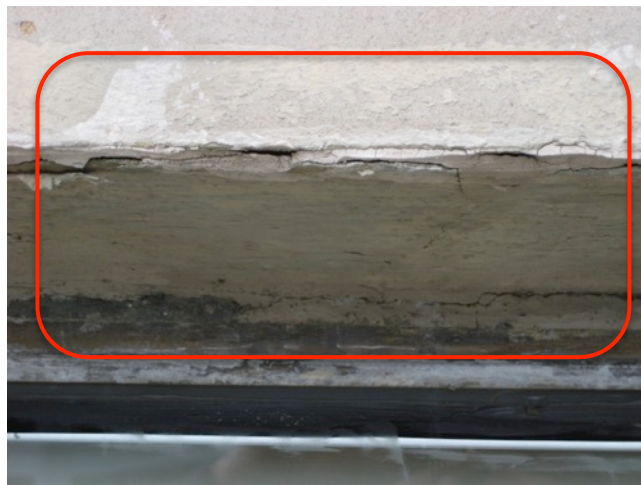
The building's terra-cotta spandrels, which separate windows vertically, displayed variable condition, ranging from still apparently decent to moderately degraded. However, reflecting these spandrels' lack of drainage provisions and lack of sill caps, many had damaged, spalling bottom edges, some showed cracking which could reflect early signs of spalling due to corrosion of embedded anchors, others had severely damaged cement-wash sills, etc.

**Fig. 3.30: Spalling, Damaged T.-C. Bottom**

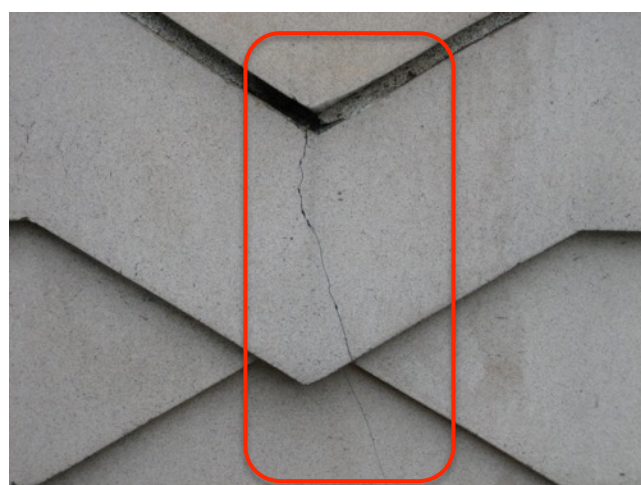
**Fig. 3.32: Cracked T.-C. Spandrel Panel**

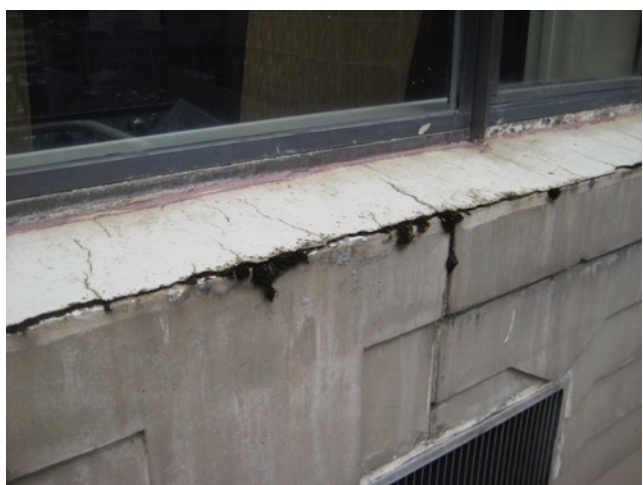
**Fig. 3.33: Failing Cement-Wash Sill**

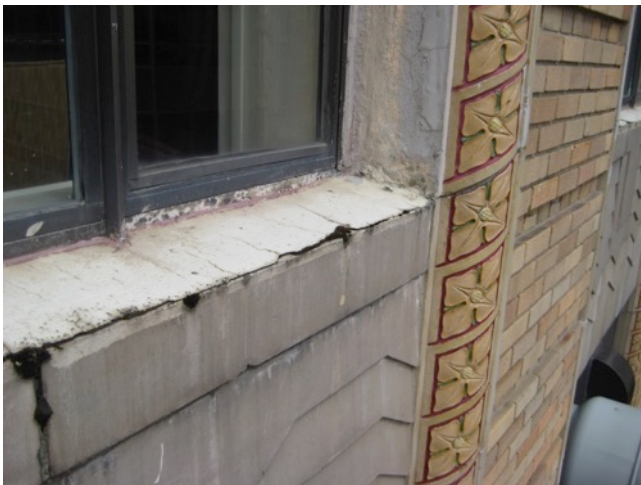
**Fig. 3.34: Failing Cement-Wash Sill**

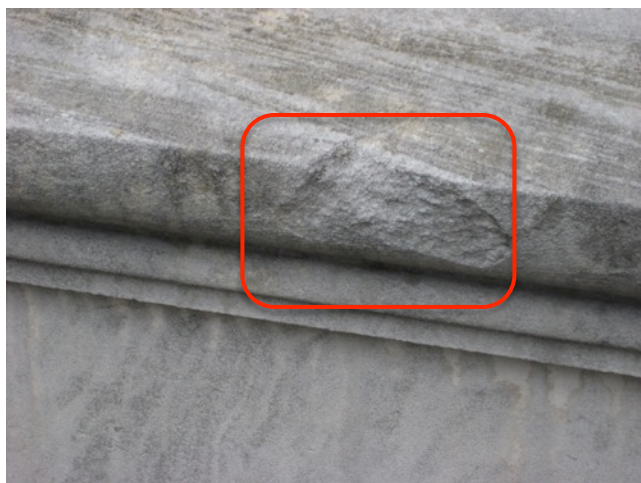
Working down the building to the Level 2 Water-Table, composed of un-capped, weather-exposed limestone, its symptoms were as expected of its design and still relatively young age. Namely, as it is always ill-advised to expose any masonry upward to the open sky, the top surface of this water-table was starting to show variable degrees of delamination, ranging from incipient and detectable, but not yet visible, to fully spalled. Vertical cracks through these pieces were scattered all around, and edge damage and spalling affected various locations.

**Fig. 3.37: Water-Table Edge Spall**

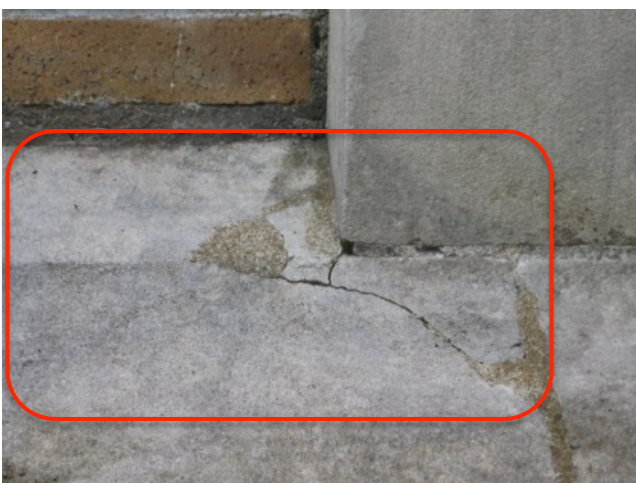
**Fig. 3.38: Water-Table Top Delamination**

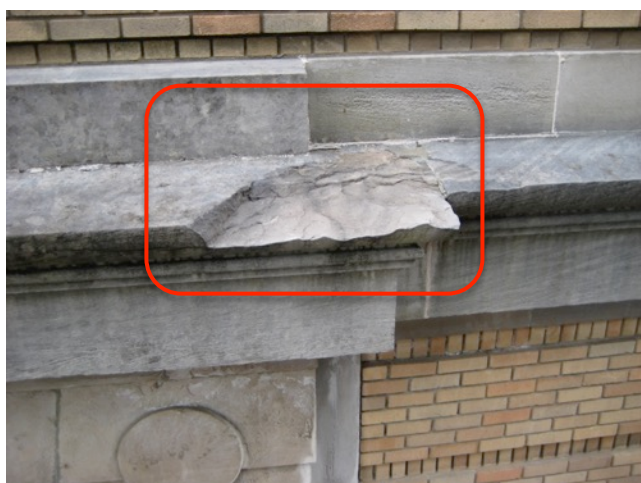
**Fig. 3.39: Water-Table Top Delamination**

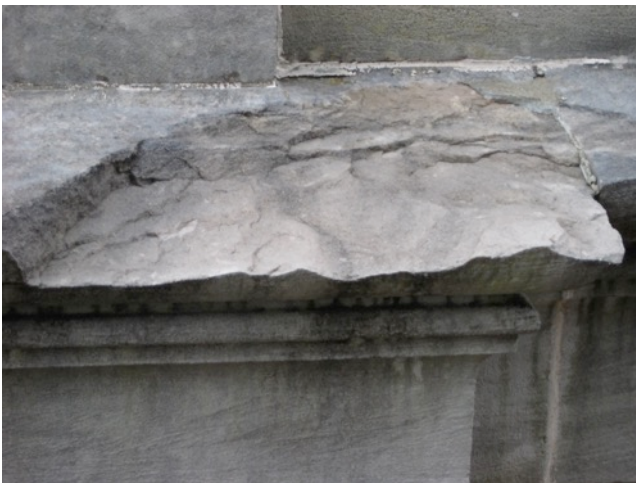
**Fig. 3.40: Close-Up of W.-T. Top Delamination**

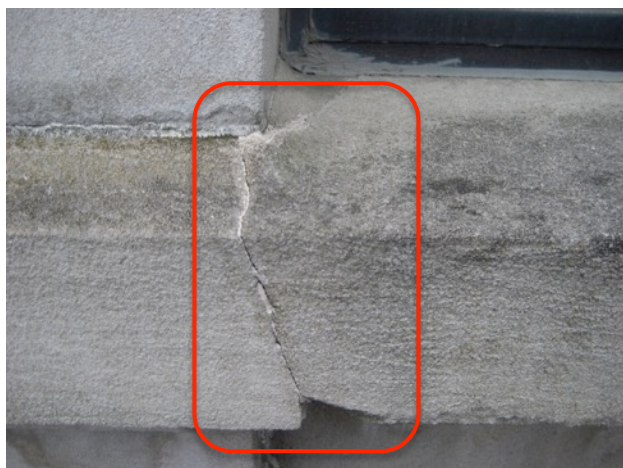
The limestone cladding extending from grade to the level 2 water-table on the building's south side also displayed an unexpectedly high degree of weathering and other symptoms for this cladding's relatively young age, reflecting in part its specific design and materials, Juneau's particularly masonry-challenging climate, as well as a history of some movement, manifesting for example by the fact that all of the ground-floor window sills were cracked through at one end. Serious differential surface erosion affected many areas, and some locations had spalled due to corrosion of embedded steel anchors.

**Fig. 3.43: Cracked Stone Sill**
