# Re-Cladding the Alaska State Capitol: A Case Study in Rational Historic Preservation

## **Primary Team Members:**

Client:	State of Alaska, Legislative Affairs Agency
Architect:	Jensen Yorba Lott Inc.
Structural Engineer:	Swenson Say Faget Inc.
Building Envelope Consultant:	Paul Lukes: Building Envelope Consulting Services LLC.
Electrical Engineer:	Haight & Associates Inc.
Mechanical Engineer:	Murray & Associates P. C.
General Contractor, Portico:	Alaska Commercial Contractors
General Contractor, Building:	Dawson Construction Inc.

This article concerns the still ongoing re-clad and seismic upgrade of the Alaska State Capitol, scheduled for completion at the end of the 2016 construction season, a project I have been involved with over the course of 11 years.

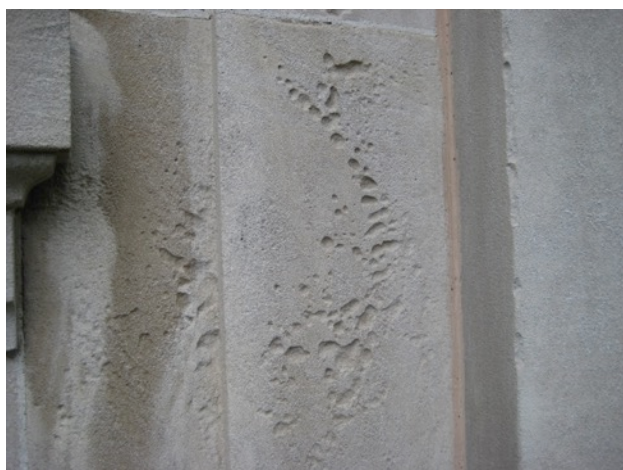
The limestone cladding extending from grade to the level 2 water-table on the building's south side also displayed an unexpectedly high degree of weathering and other symptoms for this cladding's relatively young age, reflecting in part its specific design and materials, Juneau's particularly masonry-challenging climate, as well as a history of some movement, manifesting for example by the fact that all of the ground-floor window sills were cracked through at one end. Serious differential surface erosion affected many areas, and some locations had spalled due to corrosion of embedded steel anchors.

**Fig. 3.45: Differential Surface Erosion**

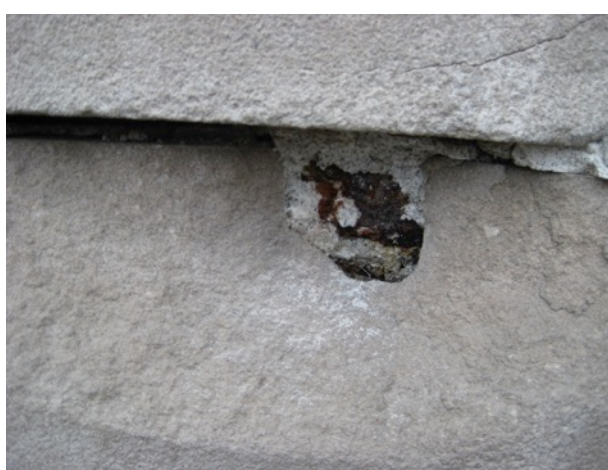
**Fig. 3.46: Spall Due to Anchor Corrosion**

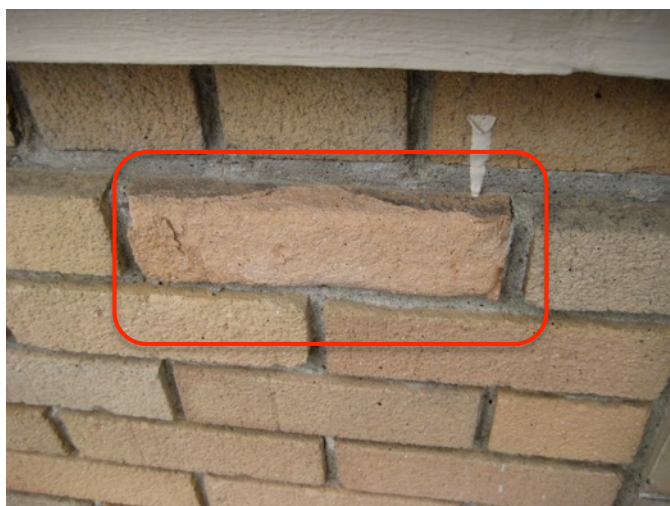
The brickwork in general displayed a far more advanced age than one would expect of 80-year old brick. In fact, during my second visit, I was also working on another historic brick building in Seattle, 25 years older than this capitol, but whose brick would not show degradation comparable to the capitol's for a good 200 years. At first, the brick's surface was so rough that I was convinced that it must have been sandblasted, a very damaging yet not uncommon practice 5-6 decades past, as I had rarely seen brick as rough which had not been blasted. However, on my 3<sup>rd</sup> visit, I was finally able to closely access the relatively weather-sheltered west face of this building's east wing, whose brick was in obviously much better condition, many decades younger in appearance. I similarly observed that the portico's marble columns remained well honed on their weather-sheltered NW faces, yet were seriously eroded on all other exposures, so I believe that the observed damage reflects Juneau's particularly masonry-challenging climate, as addressed later in this article. This, combined with aspects of the building exterior's design, significantly accelerated the masonry's weathering.

A primary design factor exacerbating this included the complete absence of through-wall flashings under sills and anywhere within the masonry, thus greatly increasing infiltration into the brick cladding, contributing to interior leakage as well. The brickwork, which is articulated with admittedly visually pleasing effect by repeating recessed coursing as well as deeply raked mortar joints, creates many small horizontal ledges which absorb water, which can spall the brick when frozen, something which happens roughly 150 times annually in Juneau. Consequently, the brickwork was significantly spalled.

**Fig. 3.47: Spalled, Eroded Brick**

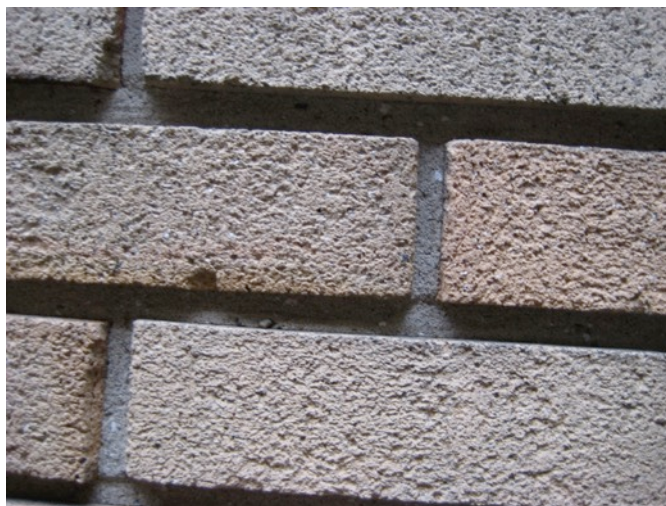
**Fig. 3.50: Eroded Brick**

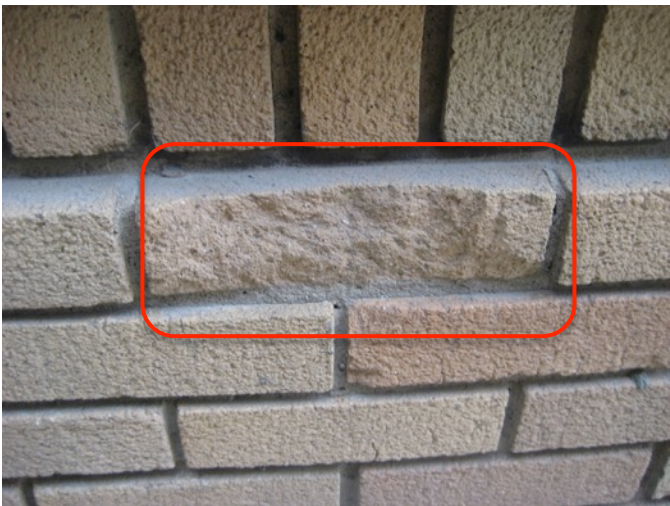
**Fig. 3.53: Spalled, Eroded Brick**

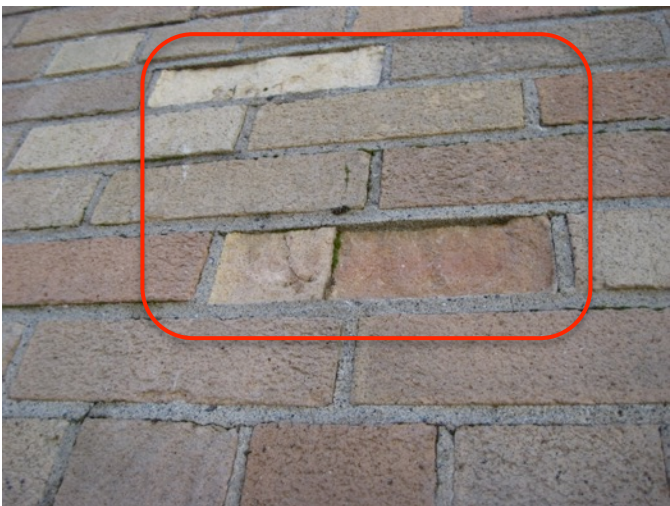
**Fig. 3.55: Spalled, Eroded Brick**

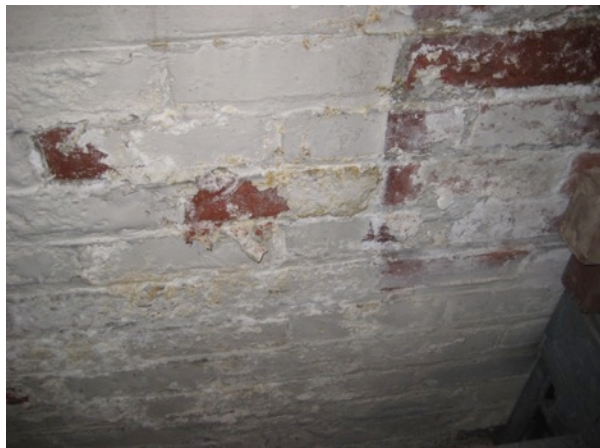
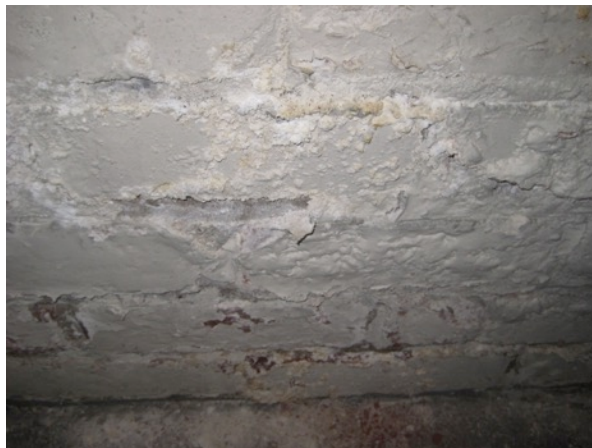
As expected, in the one location where the interior face of the brick walls could be examined, extensive interior face spalling and efflorescence were also observed, and though this was the only visible area where the interior brick face could be observed, similar degradation was likely occurring at many concealed inner brick faces.

**Fig. 3.57: Spalling & Efflor. on Int. Face** **Fig. 3.58: Spalling & Efflor. on Interior Face**

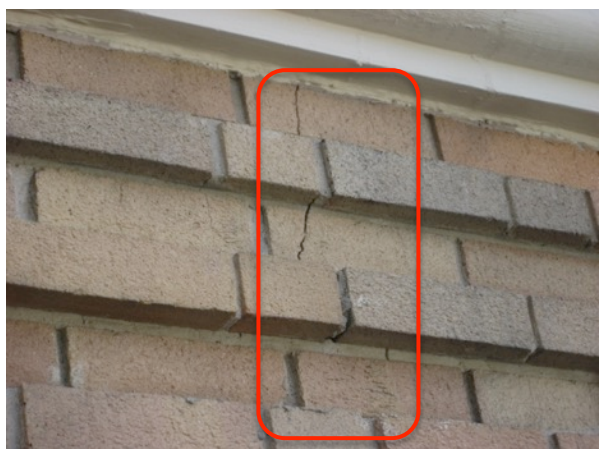
The brickwork also contained numerous cracks, most relatively short but some exceeding 10 feet in length, some penetrating vertically through the brick units and others stair-stepping through the mortar joints. In one location, a corroding window head lintel had sagged down, causing two brick courses above the lintel to sag also.

**Fig. 3.59: Vertical Brick Cracking**

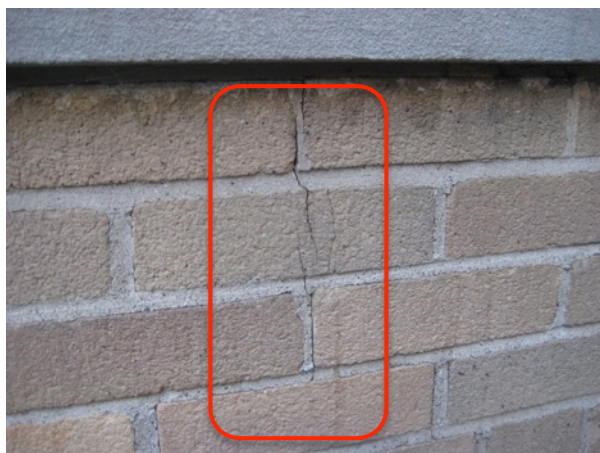
**Fig. 3.61: Vertical Brick Cracking**

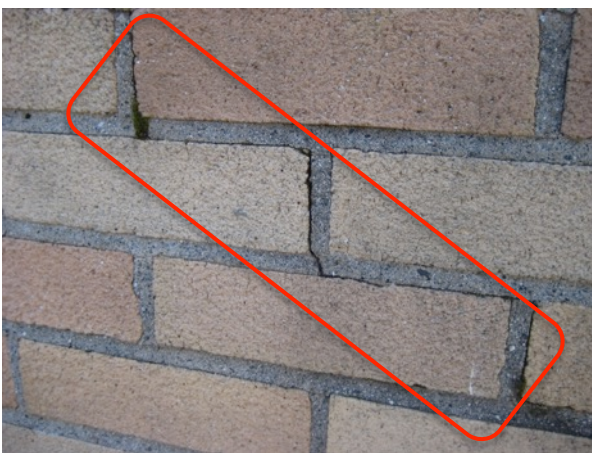
**Fig. 3.62: Stair-Step Cracking**

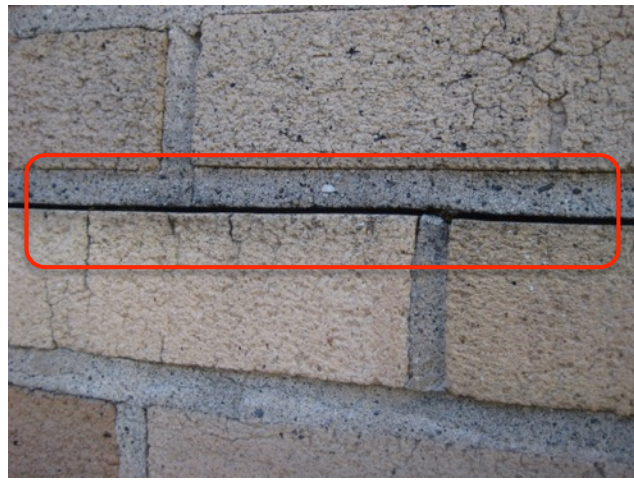
**Fig. 3.64: Horiz. Crack @ Sagging Lintel**

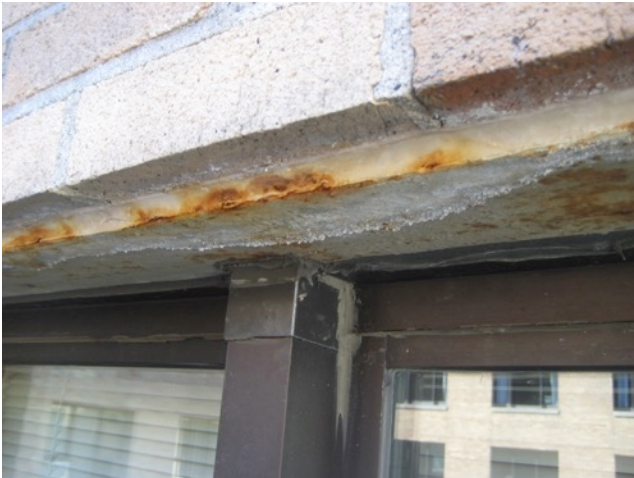
Although lintel corrosion was surprisingly limited for a building of this age in so wet a climate, variable, though generally no worse than moderate corrosion was observed at scattered locations. This was exacerbated by the complete absence of through-wall flashings above these lintels, as well as absence of any drainage provisions, with the gaps above the lintels typically sealed.

**Fig. 3.65: Lintel Corrosion**

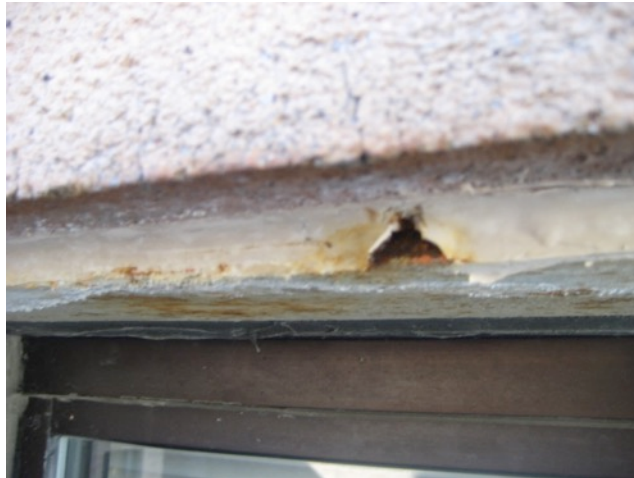
**Fig. 3.66: Lintel Corrosion**

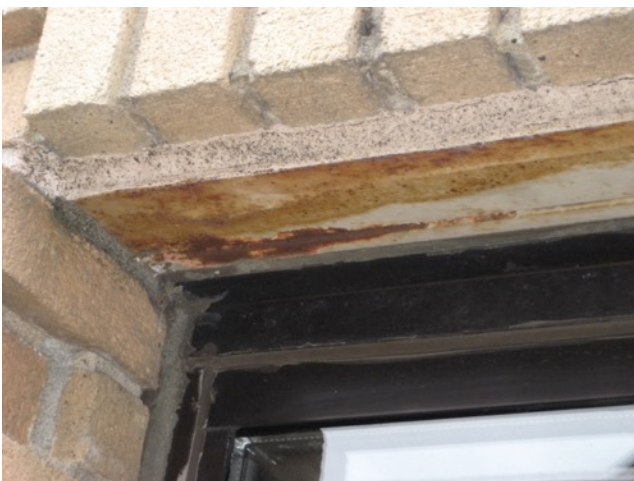
**Fig. 3.67: Lintel Corrosion**

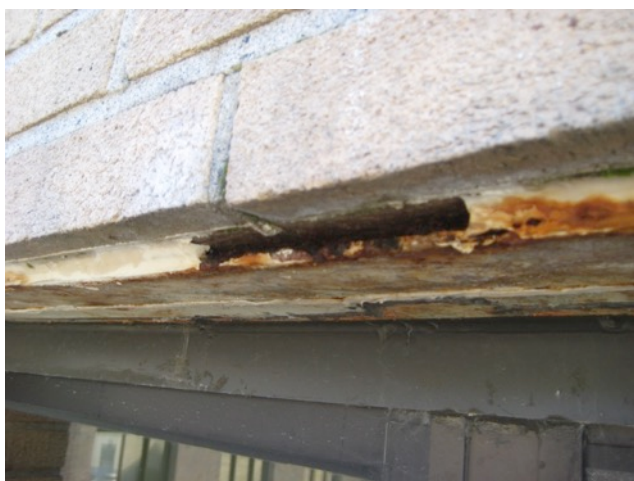
**Fig. 3.68: Lintel Corrosion**

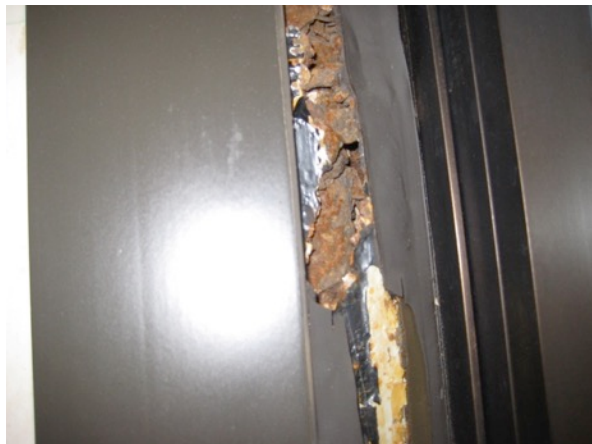
Significant interior leakage manifested near many windows, of which there were at least three distinct types, including the original steel-sash units, which were left in some locations on the lee north side, and two types of extruded aluminum windows of much more recent vintage, plausibly dating back to the 1960's, which were used at all other locations. Both of these types, however, were ill-conceived by design and improperly installed, with all possible drainage pathways mistakenly sealed with sealant. Neither window type appeared to have any integral drainage system, although many holes in the frames obviously allowed water entry into the frames. Interior leakage symptoms associated with these windows included plaster damage, elevated moisture readings, etc. In one location with a seismically-deflected window frame, severe corrosion of the steel anchorage was apparent.

**Fig. 3.69: Steel Jamb Corrosion**

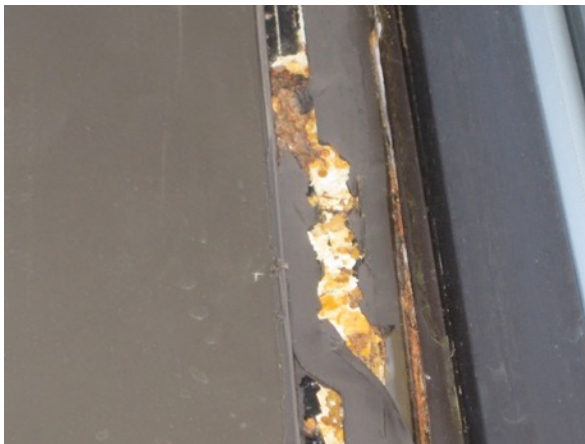
**Fig. 3.70: Steel Jamb Corrosion**

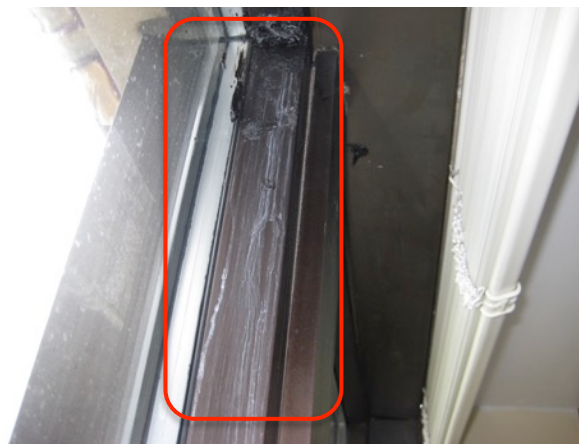
**Fig. 3.71: Lime Stains on Mullion**

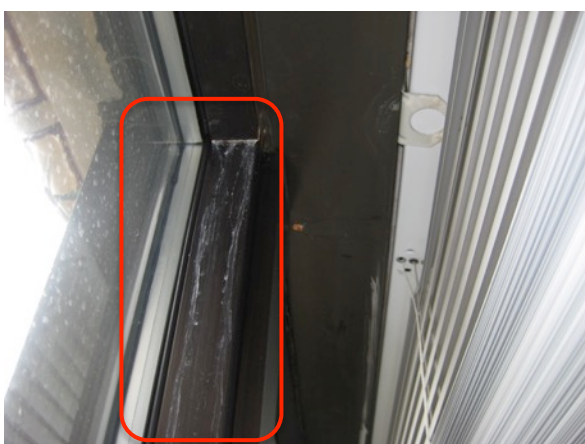
**Fig. 3.72: Lime Stains on Mullion**

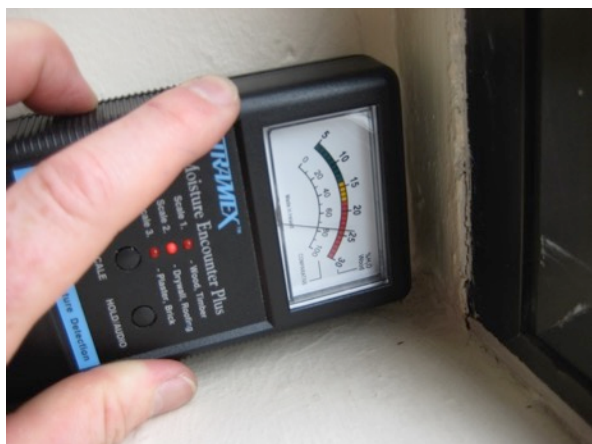
**Fig. 3.73: High Moisture @ Jamb Bott.**

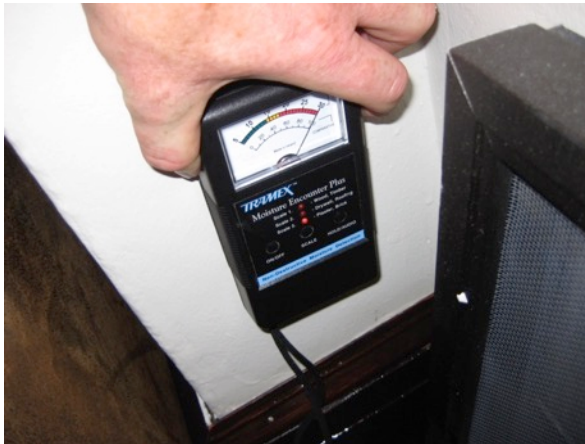
**Fig. 3.74: High Moisture Below Sill**

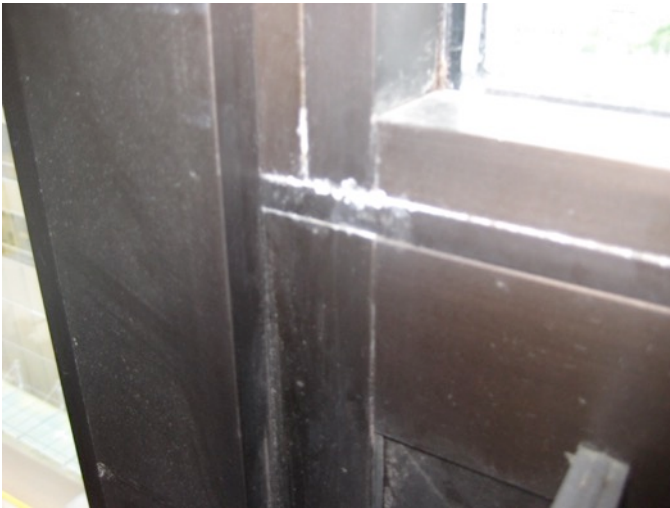
**Fig. 3.77: Lime Stains on Window Frame**

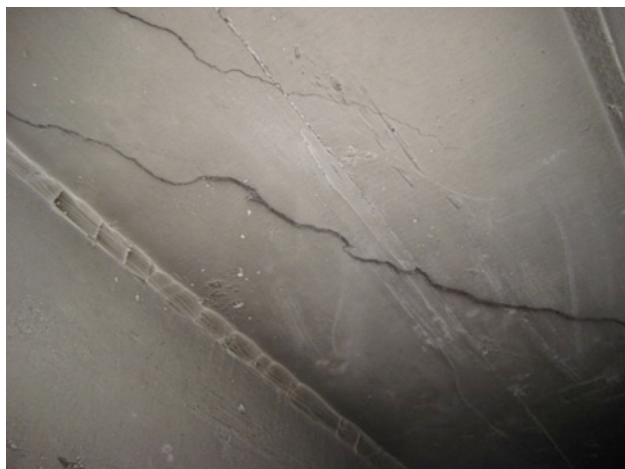
The structure itself displayed some moderate cracking of seemingly seismic origin at the ground floor concrete slab in the building's west wing.

**Fig. 3.81: Cracking of Conc. Floor Slab**

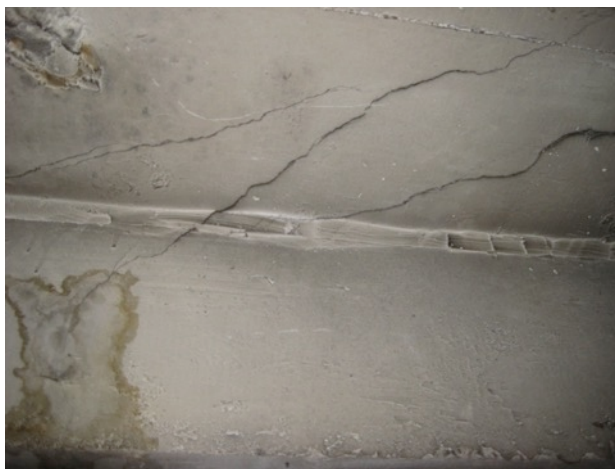
**Fig. 3.82: Cracking of Floor Slab**

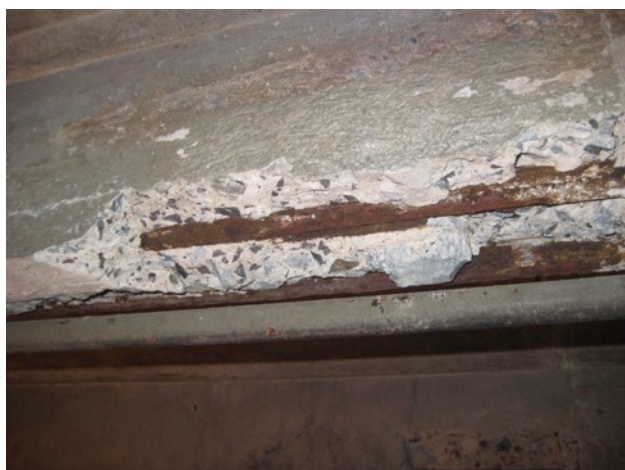
Examination of the crawl-space under the building revealed many running brooklets, as well as serious, structurally significant corrosive spalling in many concrete floor joists. Similar spalling on footings and support columns confirmed that the building's concrete base had been sucking water from the very wet soils for all of its 80 years.

**Fig. 3.83: Corrosive Spalling of Fl. Joist**

Beside the portico, the Phase 4 corrective design extended to the building's crawlspace, which would be excavated, with a new drainage system installed to contain and drain out the brooks running through the existing crawlspace, along with structural repairs to the corrosively-damaged concrete floor joists.

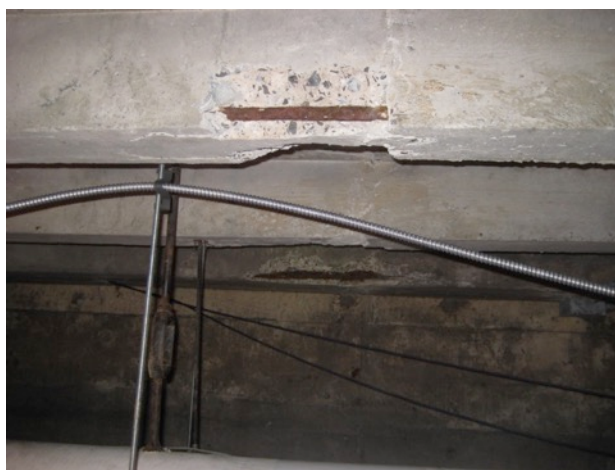
**Fig. 3.84: Corrosive Spalling of Fl. Joist**

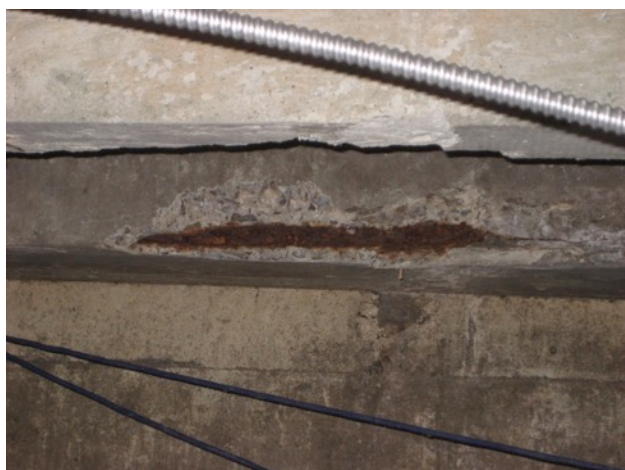
**Fig. 3.85: Corrosive Spalling of Fl. Joist**

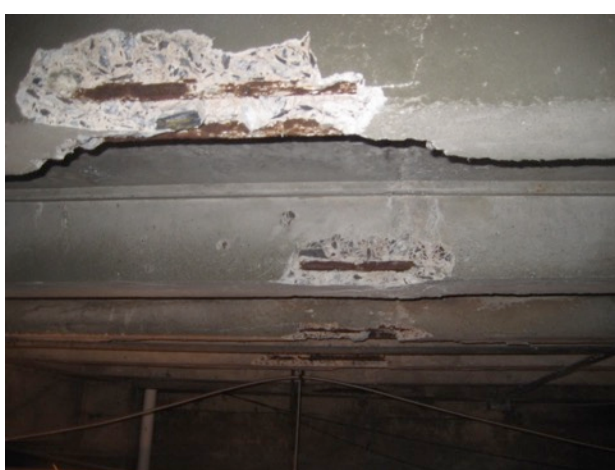
**Fig. 3.86: Corrosive Spalling of Fl. Joist**

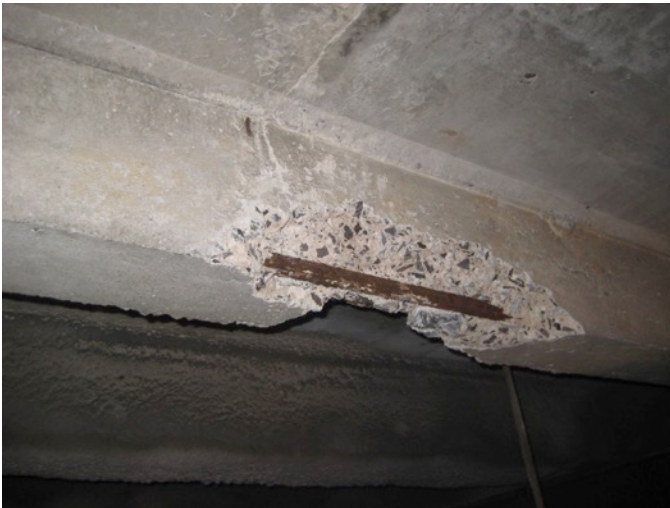
**Fig. 3.89: Corrosive Spalling of Fl. Joist**

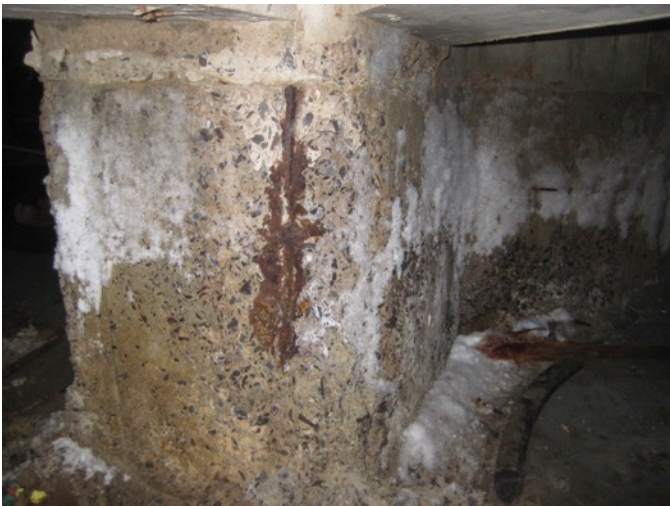
**Fig. 3.91: Corrosive Spalling, Efflor. of Pier**

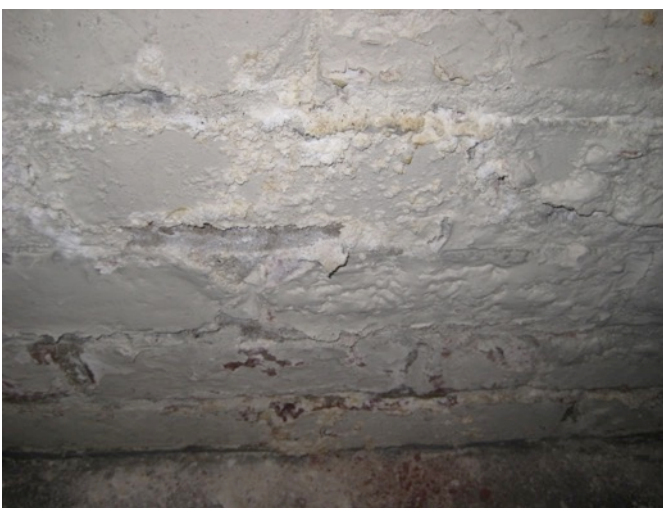
A second water-related masonry-damaging mechanism involves movement of water in one direction through masonry. On the capitol, such movement has been taking place since the building's construction, with rain water migrating inward through the brick walls. In doing so, this migrating water extracts salts from the masonry and carries these in solution toward the inner brick faces, where the water evaporates to the interior, leaving the salts near the innermost masonry face. As this process continues over decades, the concentration of salts near the inner masonry face becomes ever-greater, and much like water freezing, the crystallization of these salts within the masonry matrix causes expansion, leading to spalling and pulverization at the inner masonry faces. Where the inner face on this building could be examined, this inner-face phenomenon was also observed.

**Fig. 3.96: Spalling Interior Brick Face**

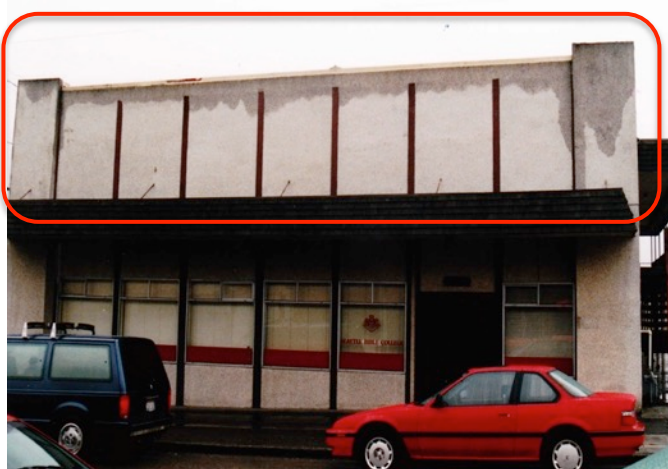
**Fig. 3.99 Wetting Pattern on Lee Side**

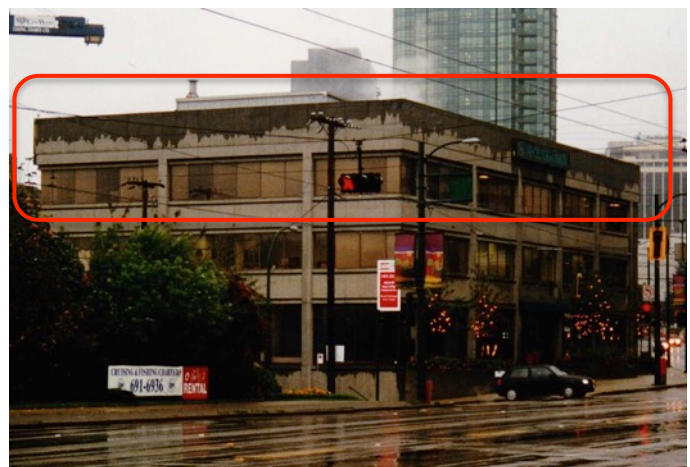
**Fig. II-3.100: 3<sup>rd</sup> Rain Day Wetting Pattern**

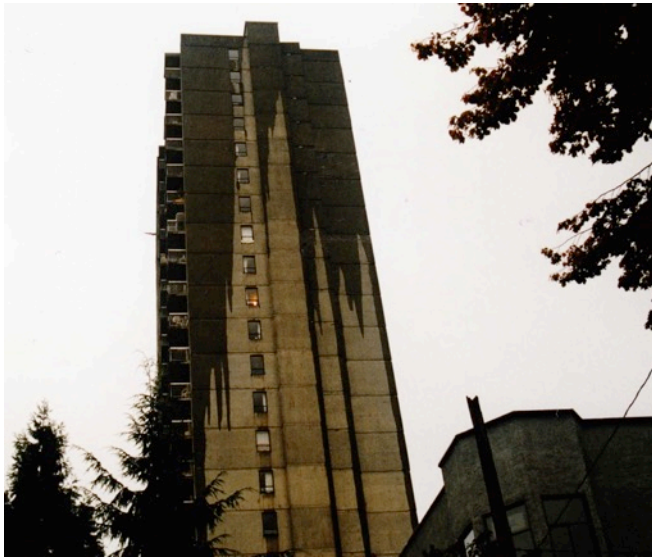
**Fig. 3.101: 3<sup>rd</sup> Rain Day Wetting Pattern**

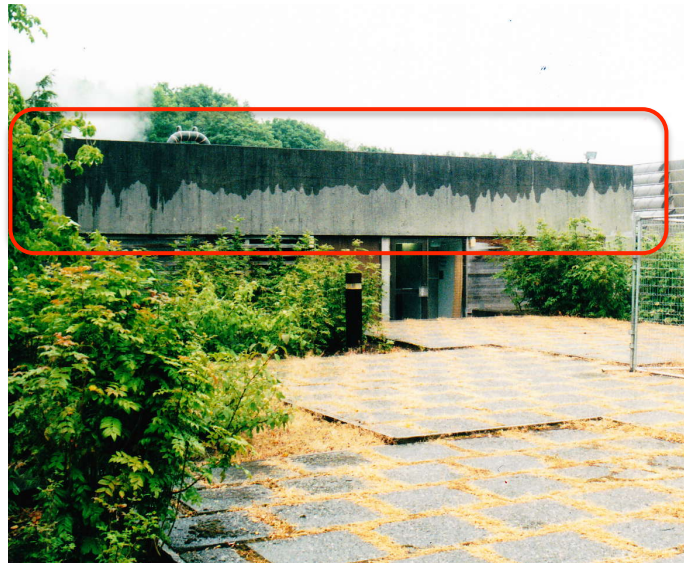
**Fig. 3.102: 3<sup>rd</sup> Rain Day Wetting**

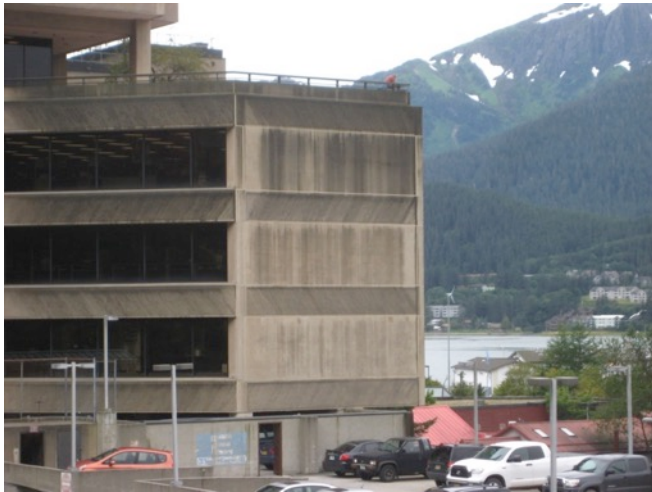
**Fig. 3.103: Stain Pattern, Juneau**

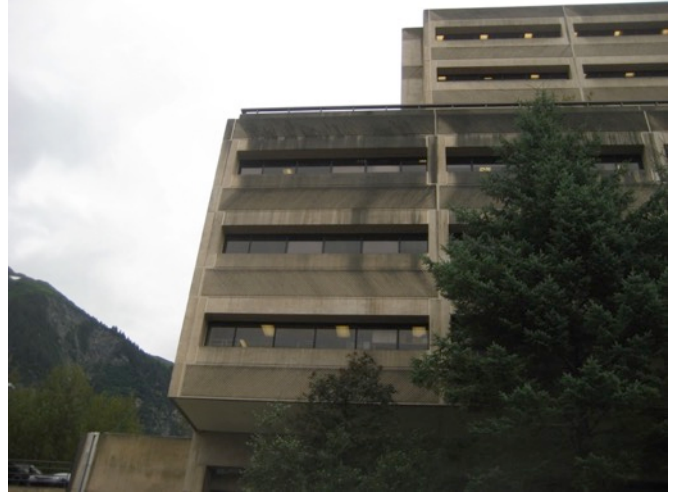
**Fig. 3.104: Stain Pattern, Juneau**

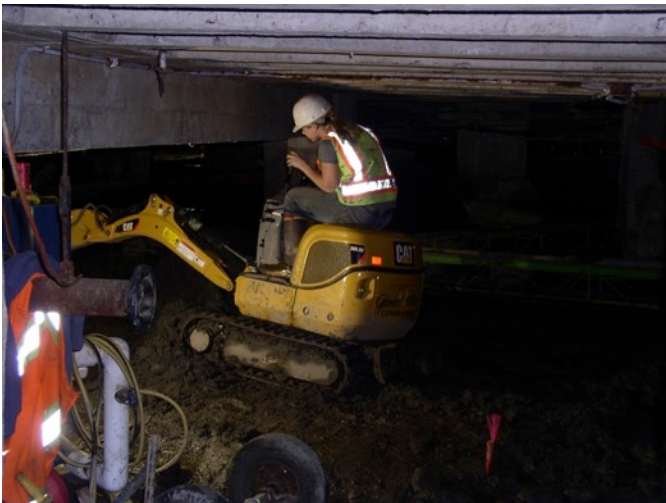
**Fig. 5.32: Excavating Crawspace**

This initial phase of the corrective work also included excavation of the very wet crawlspace under the building, installing a crawlspace drainage system, and repairing the many concrete joists and piers which had become seriously damaged by corrosive spalling. This required cutting an access hole through the building's exterior foundation wall to allow equipment access, and the very short head-room and tight spaces necessitated use of Tonka-toy sized excavation equipment.

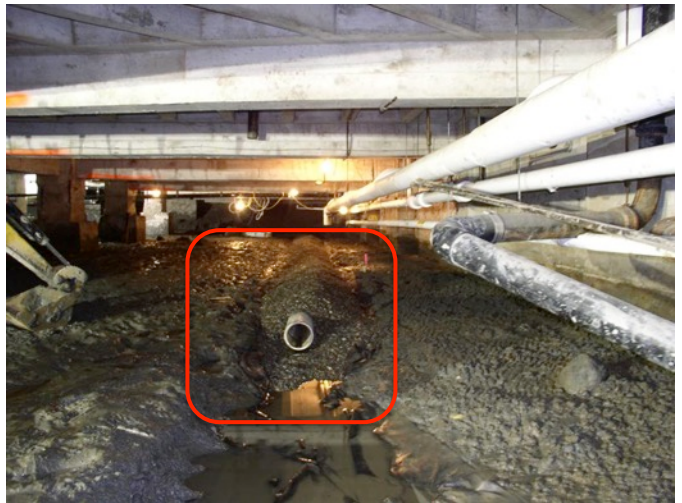
**Fig. 5.33: Crawspace Drainage System**

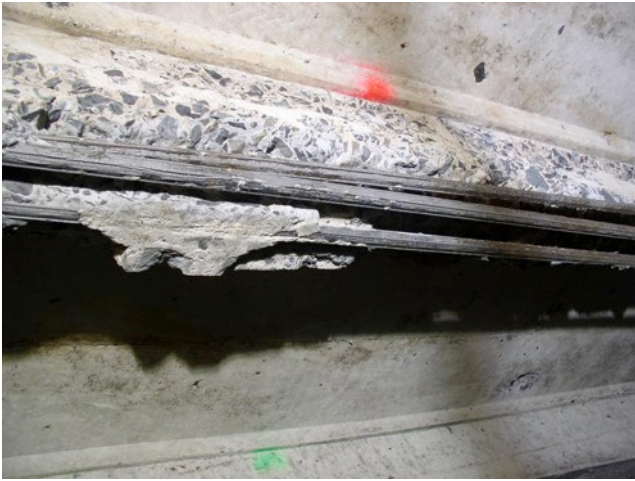
**Fig. 5.34: Cleaned-Off Joist Reinforcing**

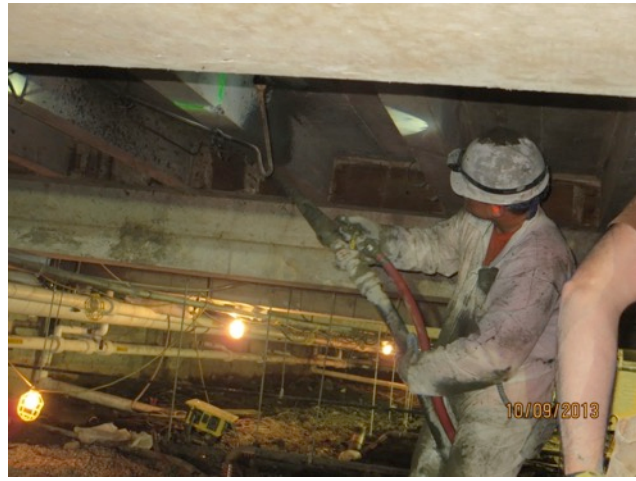
**Fig. 5.35: Shot-Creting Damaged Joist**

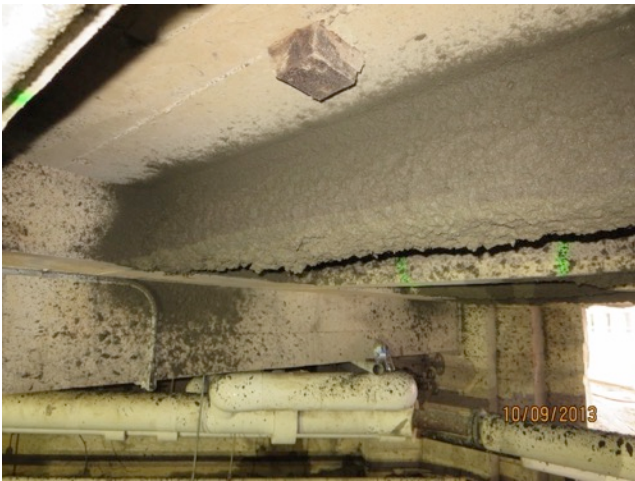
**Fig. 5.36: Repaired Floor Joist**

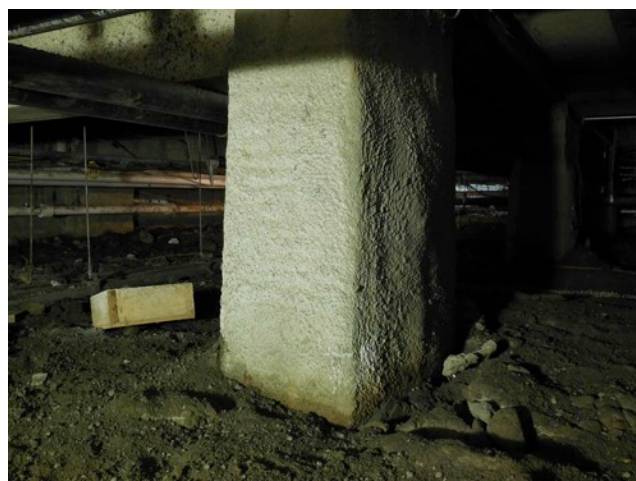
**Fig. 5.37: Repaired Concrete Pier**

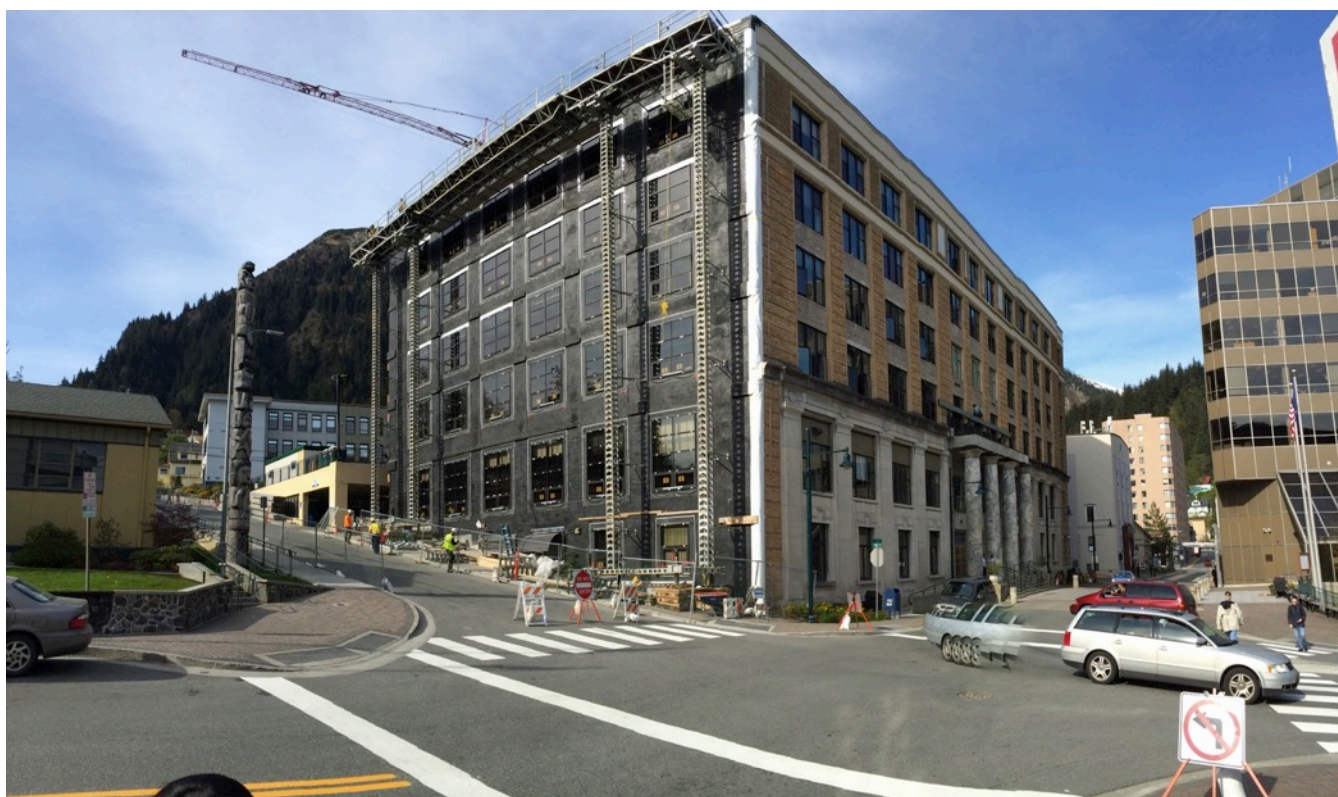
**Fig. 5.42: New Concrete Shear Walls & Windows, W. Side**

In 2014, corrective work began on the main portion of the building, starting with removal of the brick walls on the west and north sides, followed by installation of new concrete shear walls, damp-proofing, and windows, which is all Juneau's short construction season allowed, so the building was buttoned-up to make it through the winter, and the re-construction began on the west side in 2015.

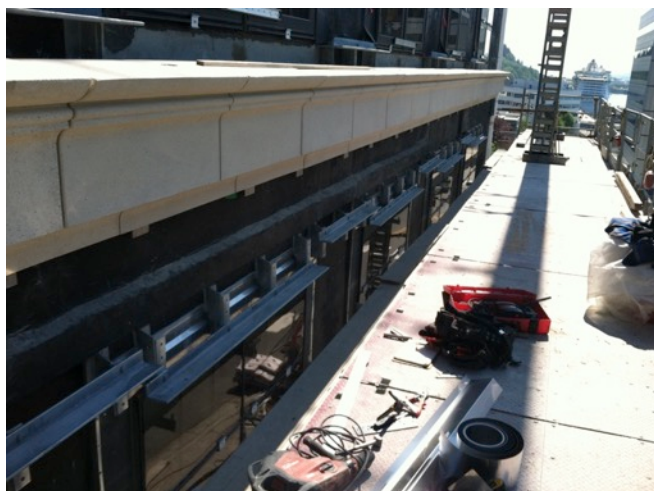
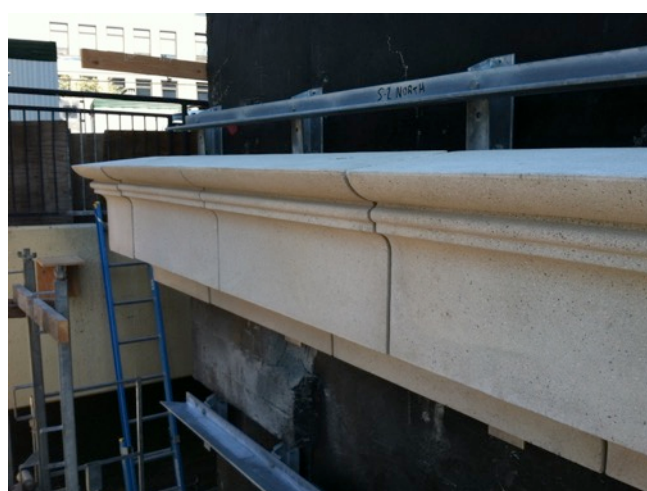
**Fig. 5.57: Level 2 Water-Table In-Progress**

**Fig. 5.58: Level 2 Water-Table In-Progress**

The level 2 water-table was rebuilt with pre-cast concrete, colored and textured to closely resemble the original stone. However, to protect its long-term integrity in Juneau's masonry-challenging climate and to preclude infiltration, it was capped with EPDM membrane overlaid with a thin vent mat and 16 ounce copper flashing caps, with type 304 stainless-steel counter-flashings used at concealed locations.

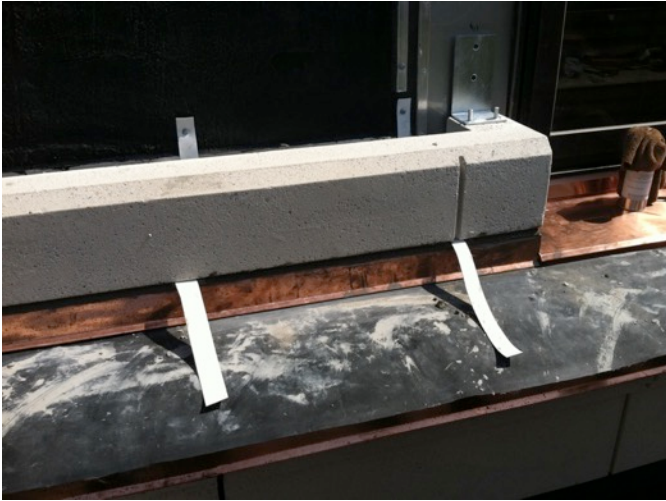
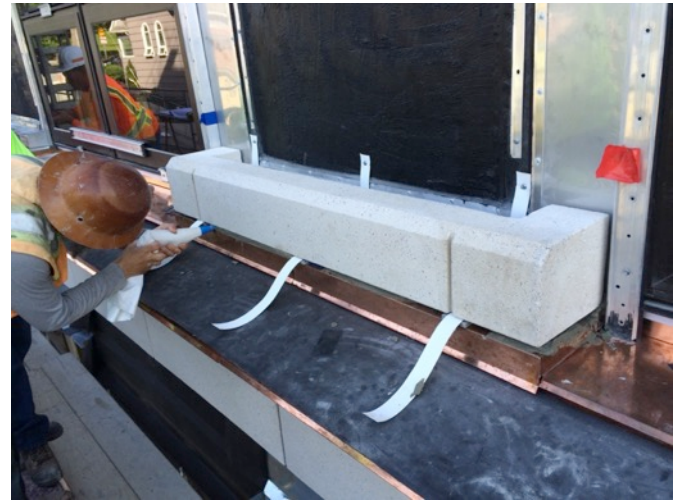
**Fig. 5.62: Pre-Cast Conc. Sill With Weeps**

**Fig. 5.63: Pre-Cast Conc. Sill With Weeps**

Pre-cast concrete “sills”, colored and textured to closely resemble the original stone “sills”, were placed atop the level 2 water-table, with drainage weeps under these to allow water to drain out from behind the masonry.

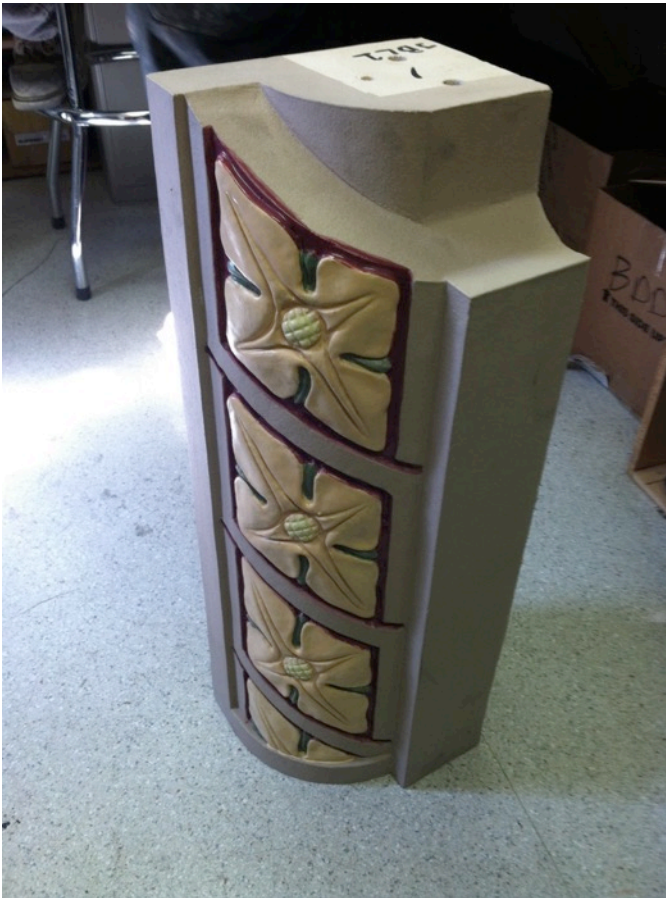
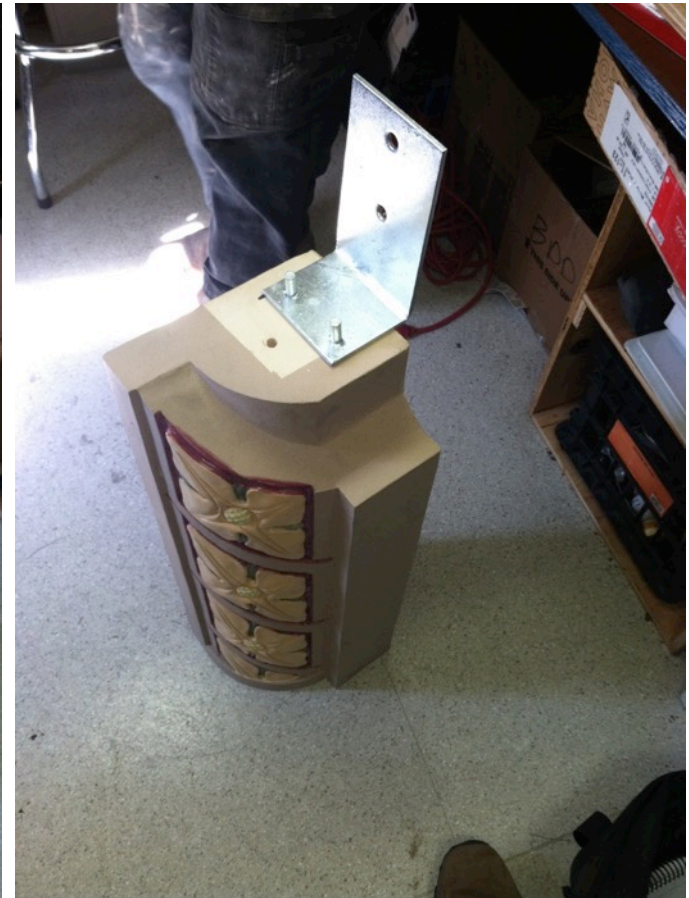
**Fig. 5.64: Replicated T.-C. Window Surround**

**Fig. 5.65: T.-C. Window Surround & Anchor**

The original multi-colored terra-cotta window surrounds were replicated in terra-cotta, but rather than being grouted in place, the new pieces were secured using type 304 stainless-steel pin-anchors, and were left hollow with drainage weeps to allow water to drain down. To accommodate thermal and moisture expansion and contraction, which on these 35-foot tall jambs could exceed  $\frac{1}{4}$ ", the pieces were adhered to the anchors using a high-modulus silicone adhesive, rather than rigid epoxy.

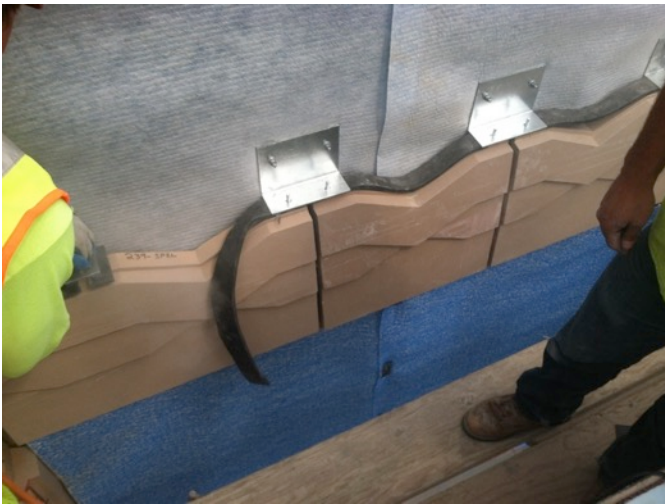
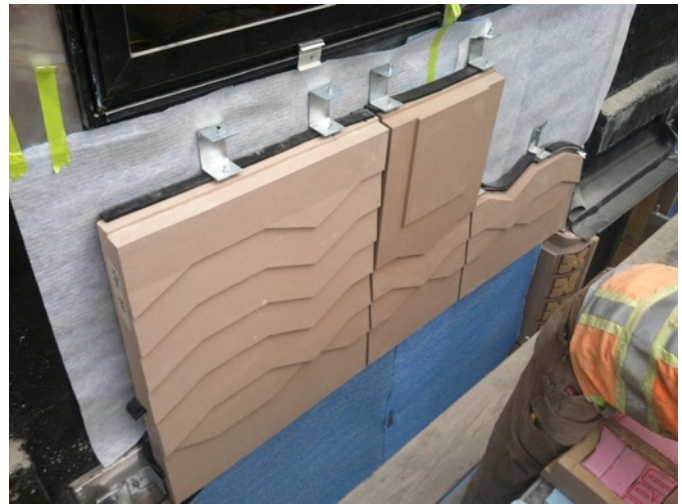
**Fig. 5.68: Start of T.-C. Spandrel Installation Fig. 5.69: Terra-Cotta Spandrel Installation**

Similarly, the original terra-cotta window spandrels were also replicated in terra-cotta, and were secured with stainless-steel pin-anchors, again using a high-modulus silicone adhesive, rather than rigid epoxy.

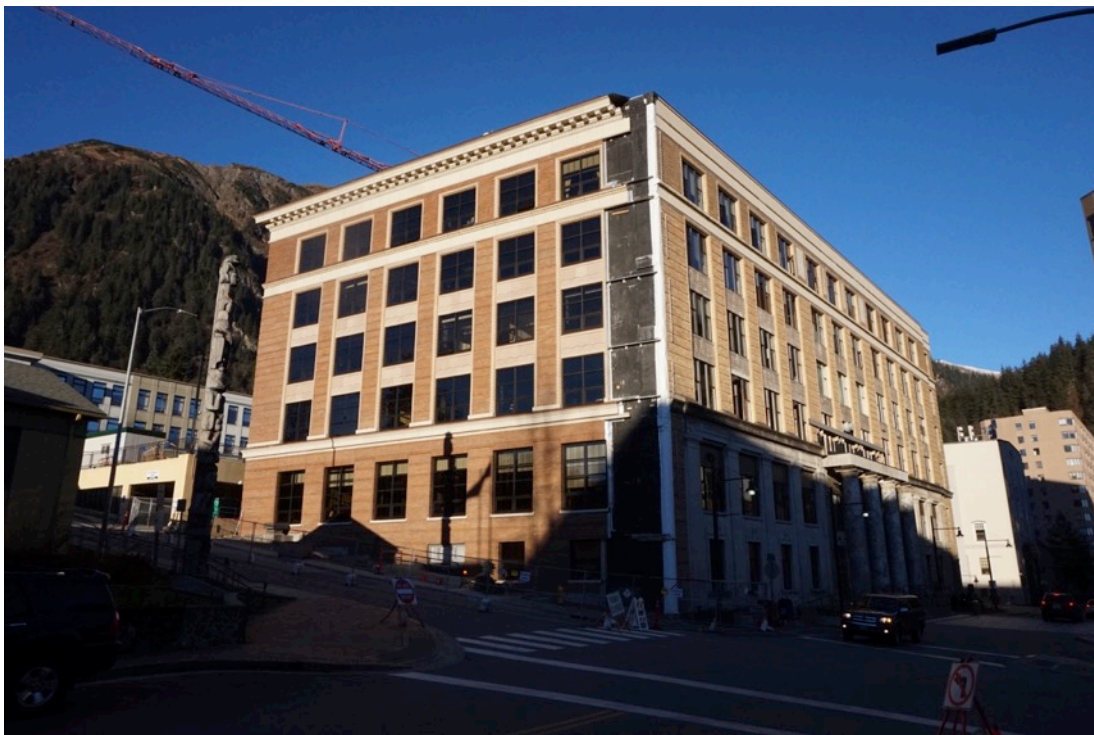
**Fig. 6.1: In-Progress Re-Cladding of the Alaska Capitol, West Side**  
New cladding is left of corner, existing building is right of corner.
